Alaska Department of Environmental Conservation (ADEC) Solid Waste Program (Kym Bronson and Kit Persson) conducted a Coastal Impact Assistance Program (CIAP), Waste Erosion Assessment and Review (WEAR) site visit for Anvik on September 12th, 2013. Alberta Walker, IGAP Assistant, participated in the site visit. The following narrative is a brief description of our findings during the September inspection.

WEAR Sites

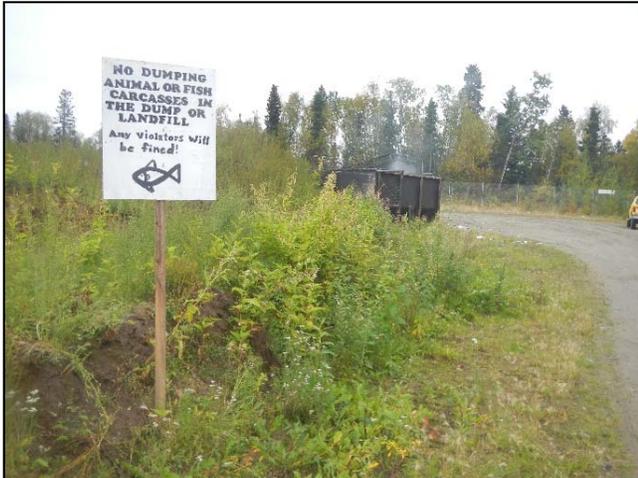
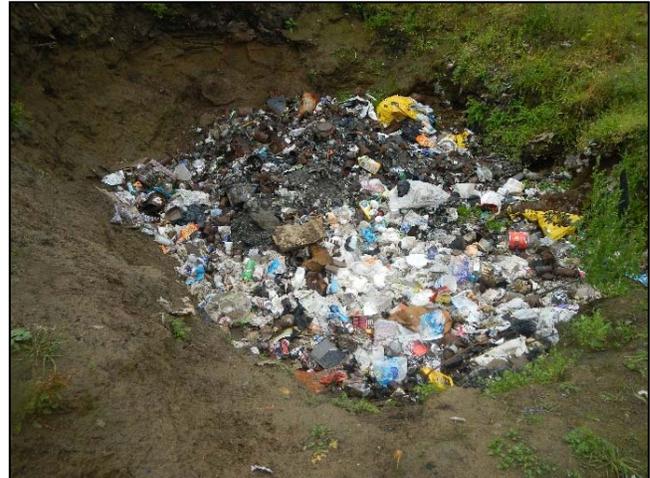
- **Landfill, 62.644426/-160.206985 (Active)** – The landfill is well run and the entire 1.9 acres is fenced. The landfill was built in 1985 as part of an effort to relocate landfills that were near active runways. Access is not restricted, and residents self-haul trash, but most waste was properly placed in the Summit Burn unit or the two general waste cells. Oil drums, scrap metal, appliances, and electronics are placed in clearly marked areas. The site is run by the City, with some assistance from the IGAP program. The landfill site is on a hill, a little more than 4,200 feet from the Yukon River.

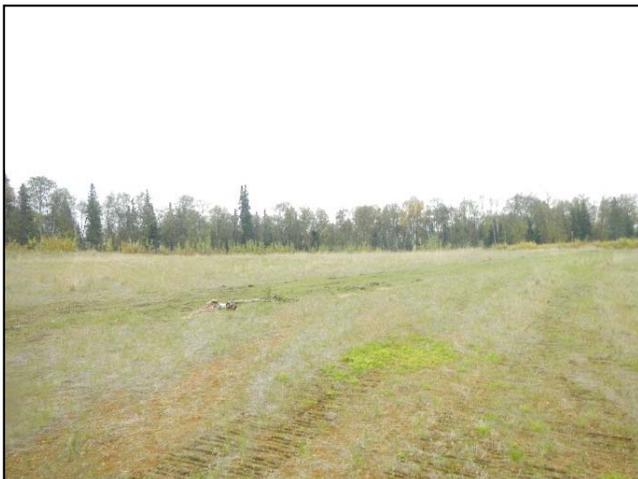
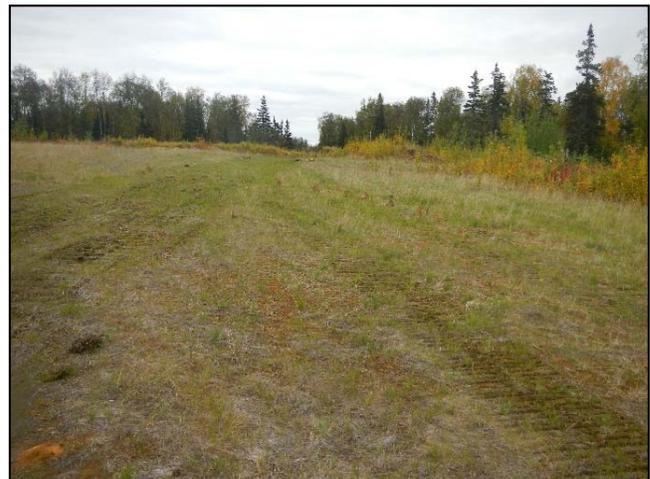
- **Runway Landfill, 62.638079/-160.191231 (Retired)** – The old landfill was near the runway and closed around 1985. It occupied approximately 3.5 acres and contained municipal waste. The site appears well covered and re-vegetated. It is located approximately 2,900 feet from the Yukon River.

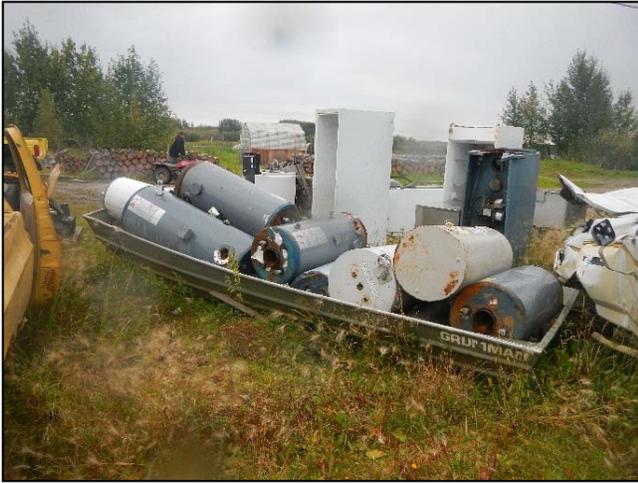
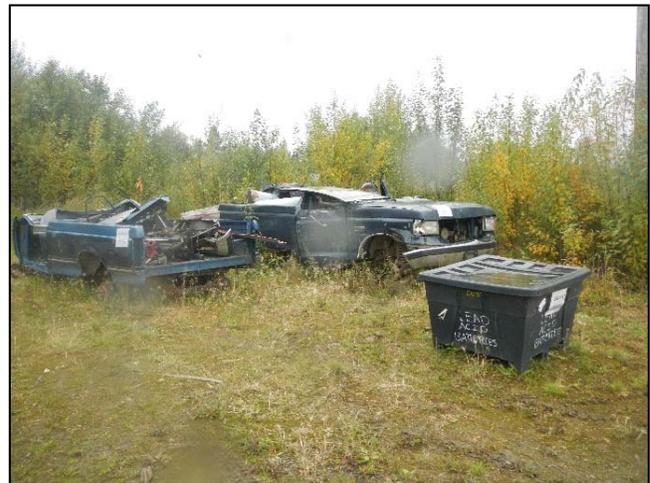
- **Bulk Waste Storage, 62.65579/-160.205978 (Active)** –This is a small site (0.8 acres) on the north end of the community. It serves primarily as the storage and backhaul staging area for junk cars, snow machines, boats, white goods, lead acid batteries, and old water heaters. It is located approximately 175 feet from the eroding bank of the Yukon River.

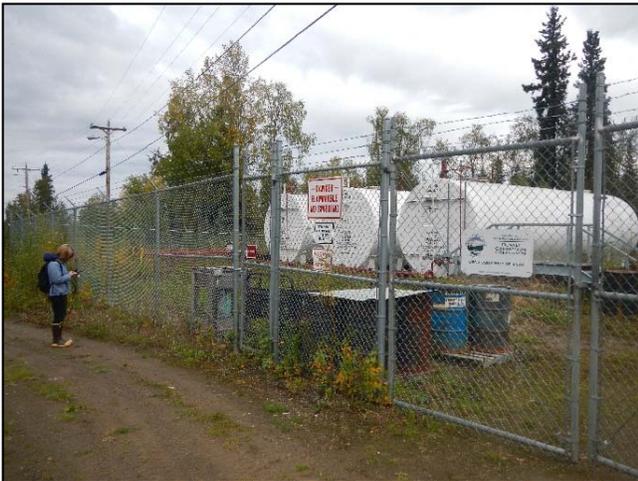
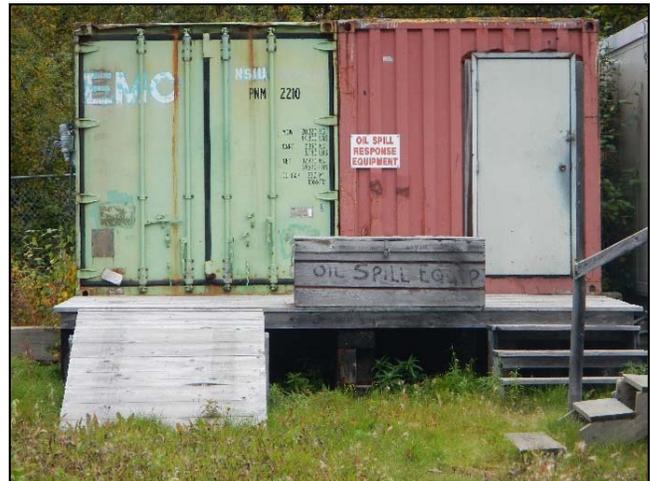
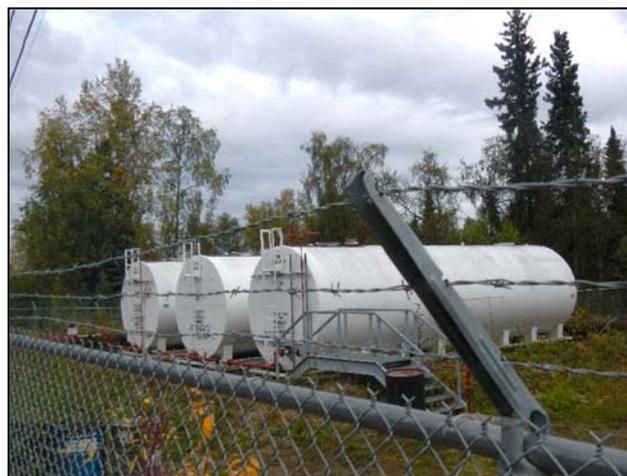
- **AVEC Tank Farm, 62.649748/-160.193955 (Active)** – This tank farm was constructed in 2002 by the Denali Commission and AVEC. The site is located across from the school and contains 3-27,000 gallon, single wall, diesel tanks within a lined earthen berm area. There is a clearly marked Connex containing oil spill equipment. The tank farm supplies diesel to the power plant for the community. The site is entirely fenced. The site is roughly 0.5 acres in size and 2,400 feet from the Yukon River.

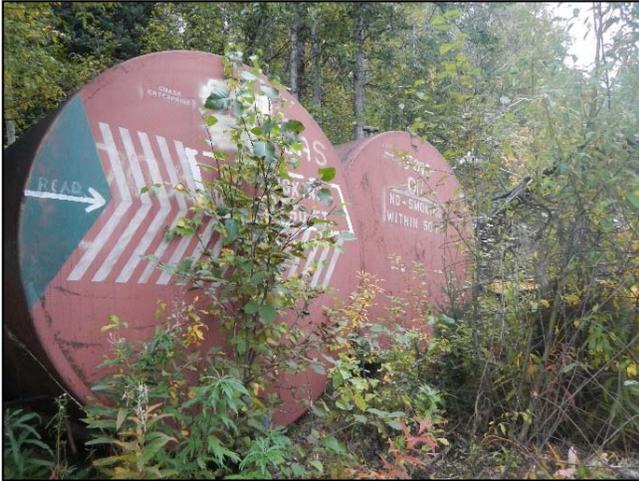
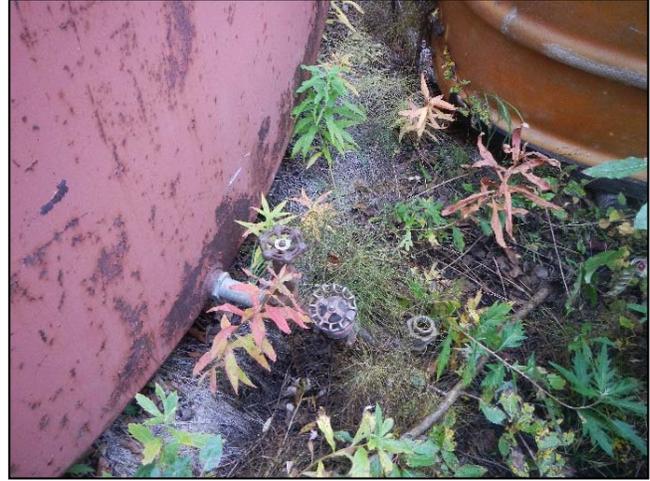
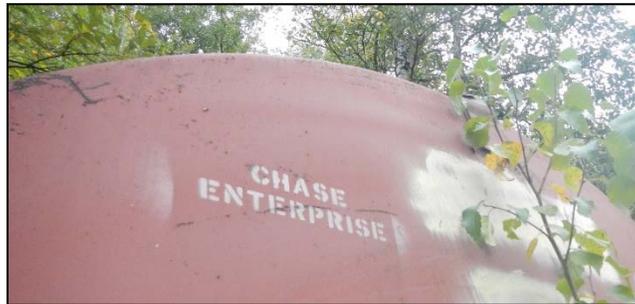
- **Chase Enterprise Store Tank Farm, 62.655948/-160.203445 (Active)** –These two tanks are an active Contaminated Site (File ID 2405.38.004) due to petroleum contamination. The tanks were owned and operated by Ruby Chase with the Chase Enterprises Store. Each tank held 5,250 gallons, one is labelled “Gas” and the other “Stove Oil”. The tanks were in operation in 1998, but had been abandoned by 2000 per the Contaminated Sites database. There is no secondary containment or liner and no fencing to prevent access. The tanks are resting directly on the ground with stressed vegetation noted. It is located approximately 185 feet from the eroding bank of the Yukon River.

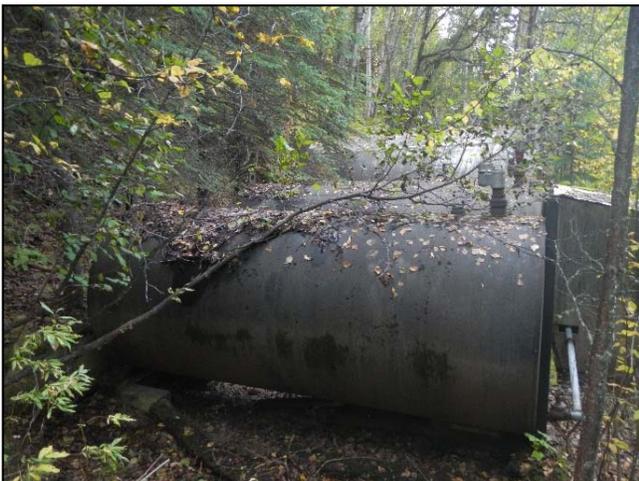
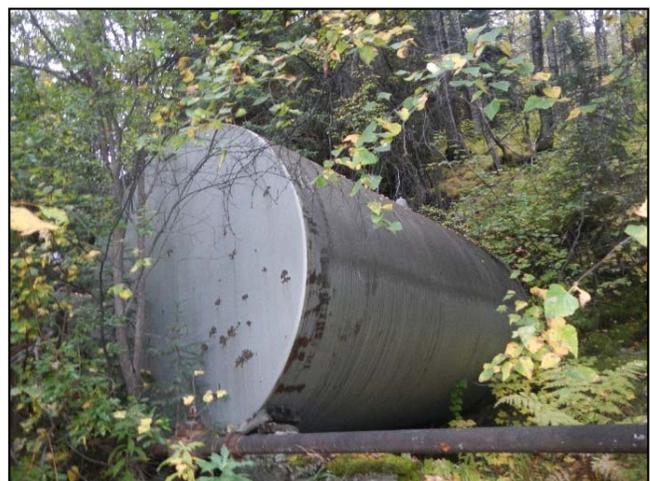
- **Anvik Commercial Co. Tank Farm, 62.656503/-160.202771 (Active)** – This site is located northeast of the Anvik Church and is an active Contaminated Site (File ID 2405.38.005) due to petroleum contamination. It consists of the overgrown remains of a gas station and tank farm owned by the Anvik Commercial Company. It was reportedly closed in the early 1990s, however in 1998 this tank farm was listed as open on the Denali Commission website. There are four horizontal tanks (total capacity 21,835 gallons), dispenser shed, and gas pump present. When in use, the tanks stored gasoline and diesel. The entire site is not fenced and is accessible. It is located approximately 60 feet from the eroding bank of the Yukon River.

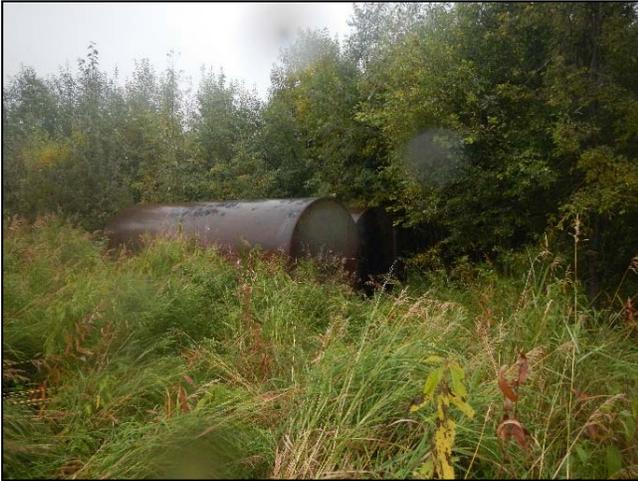
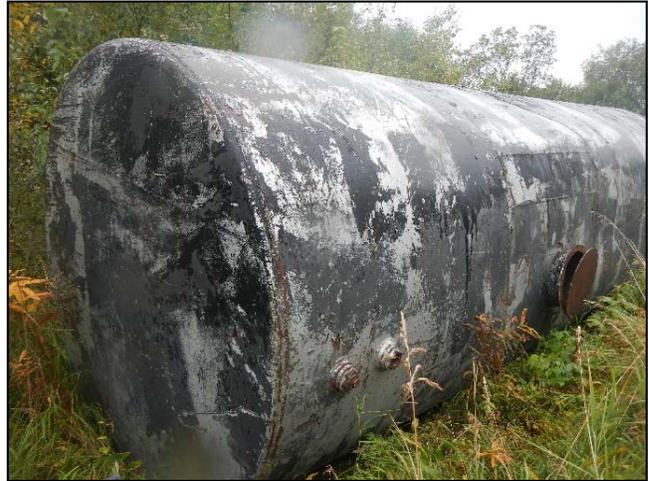
- **Deloy Ges Inc. TF#1, 62.655695/-160.206624 (Active)** – This is an active Contaminated Site (File ID 2405.38.008) due to petroleum contamination. It is owned by the Deloy Ges Corporation. This site contains three horizontal tanks, with a total capacity of 20,310 gallons. The tanks stored gasoline, diesel and aviation gasoline. Tanks are abandoned and according to a local source, during the 1994 spring flood, the tanks were "floating around" and had spilled their contents. The tanks were in use until around 2000. There is no secondary containment or liner and no fencing to prevent access and the tanks are located directly on the ground. It is located 200 feet from the eroding bank of the Yukon River.

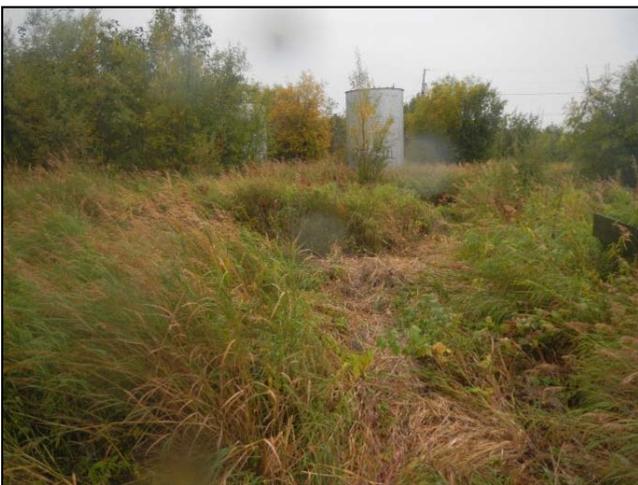
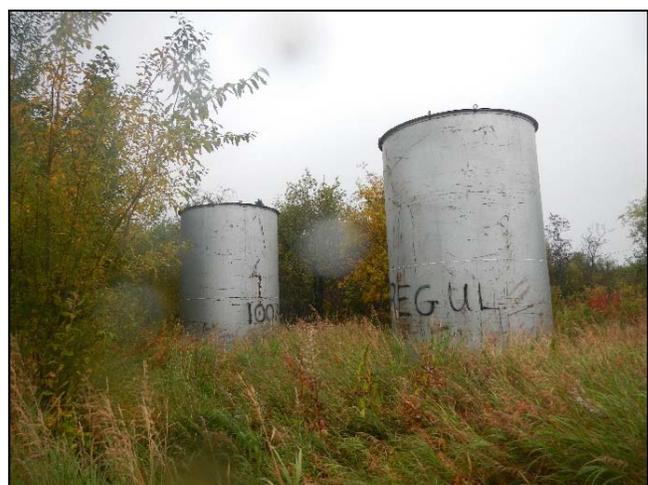
- **Deloy Ges Inc. TF#2, 62.655618/-160.207115 (Active)** – This is an active Contaminated Site (File ID 2405.38.003) due to petroleum contamination. It is owned by the Deloy Ges Corporation and is approximately 85 feet west of the Deloy Ges Inc. TF#1. This site contains two vertical BIA style tanks (total capacity of 9,180 gallons). The tanks were used to store gasoline and aviation gasoline. The site has no liner, secondary containment or fencing and the tanks are located directly on the ground. It is located 230 feet from the eroding bank of the Yukon River.

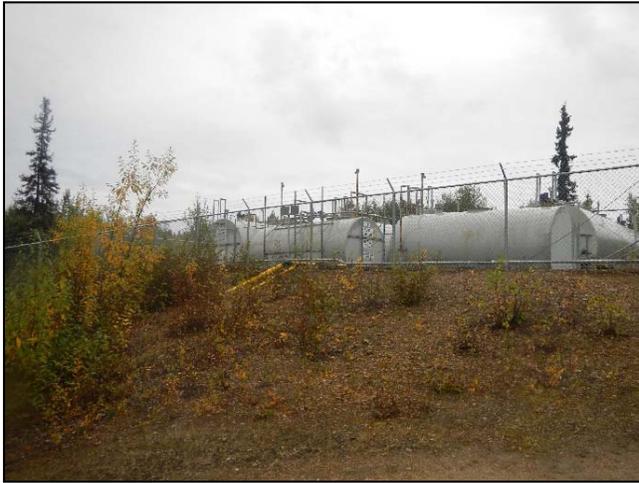
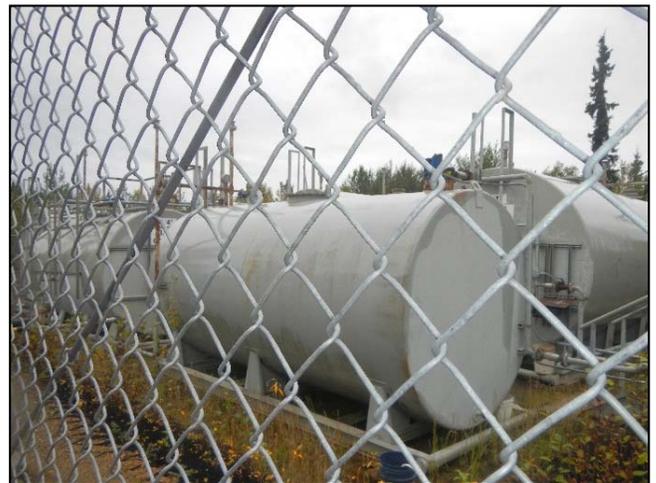
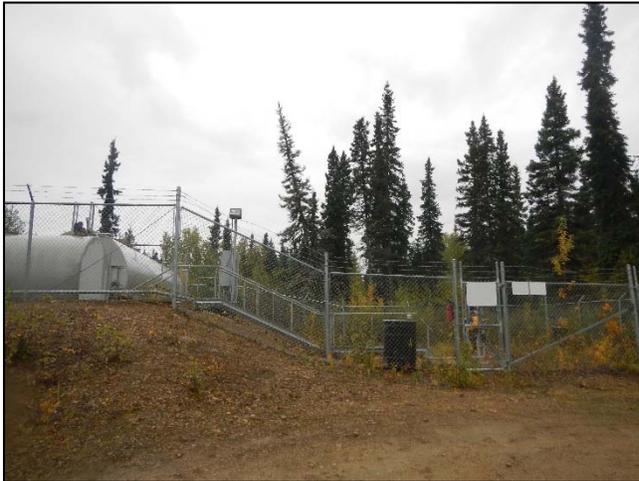
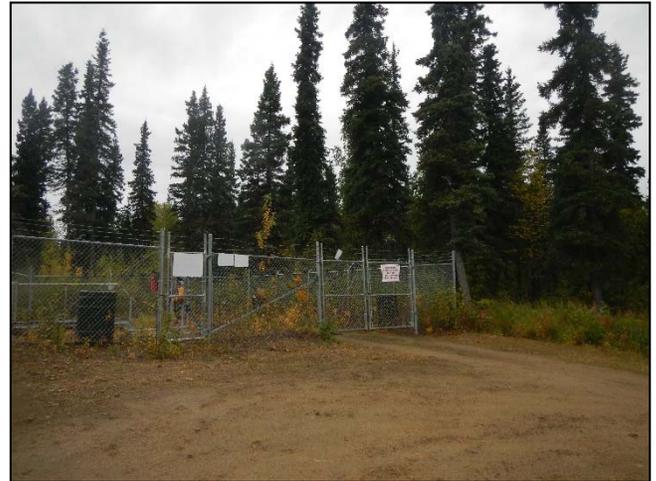
- **Deloy Ges Corporation Tank Farm and Gas Station, 62.654525/-160.206893 (Active)** – This is a newer consolidated tank farm with a total of 6 fuel tanks: 2-3,000 gallon diesel tanks, 3-10,000 gallon diesel tanks, and 1-25,800 gallon gasoline tank. It is owned by the Deloy Ges Corporation. The tanks are in a lined containment berm located within a fenced area. It is located approximately 650 feet from the eroding bank of the Yukon River.
