Alaska Department of Environmental Conservation (ADEC) Solid Waste Program (Doug Huntman and Rebecca Colvin) conducted a Coastal Impact Assistance Program (CIAP), Waste Erosion Assessment and Review (WEAR) site visit for Kwethluk on August 31st, 2012. Ruel McDalton, IGAP Coordinator for the Village of Kwethluk, participated on the site visit. The following narrative is a brief description of our findings during the August inspection.

WEAR Sites

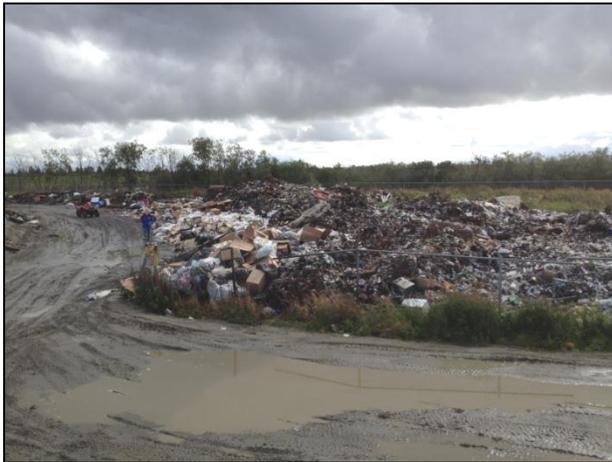
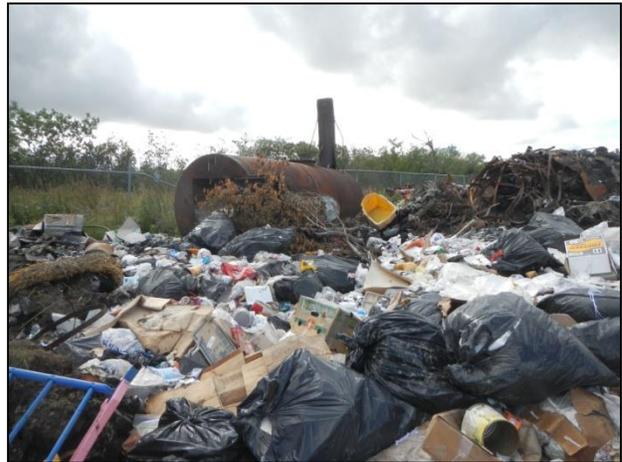
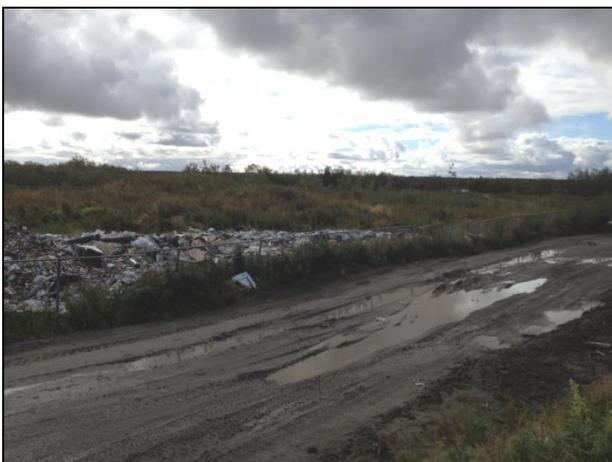
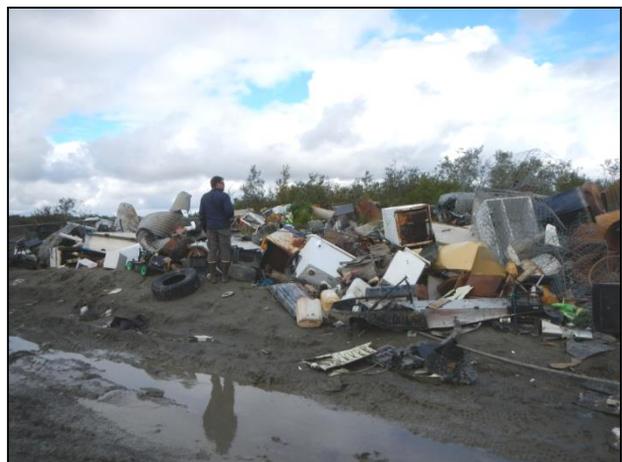
- **Landfill, 60.80414/-161.431632 (Active)** – The landfill is a 1.4 acre self-haul landfill located 1,500 feet from the nearest structure. The landfill is owned by the Organized Village of Kwethluk and operated by the City of Kwethluk. The landfill is located on semi-discontinuous permafrost and has a silty soil. The landfill was very wet during the time of the inspection, indicating an impact to the permafrost underneath the site. The site is adjacent to the honey bucket lagoon. The landfill accepts municipal wastes, but does not prohibit any special wastes or hazardous wastes. The landfill's operations are very basic: there is no cover material, no heavy equipment for consolidation/compaction, and they open burn. There was a large amount of contractor waste in the landfill at the time of the inspection. The site is located 2,650 feet from the Kwethluk River and 3,675 feet from the Kuskokuok Slough.

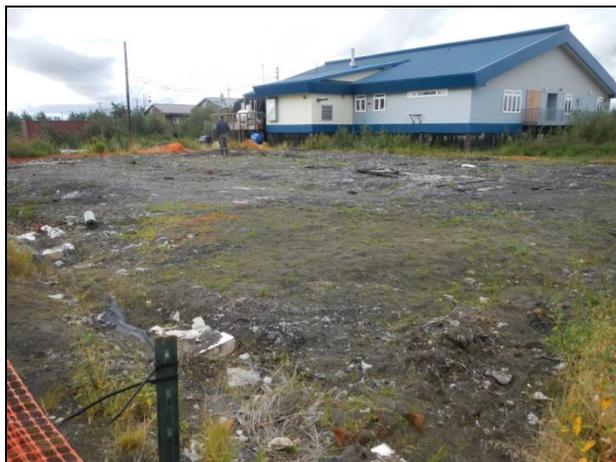
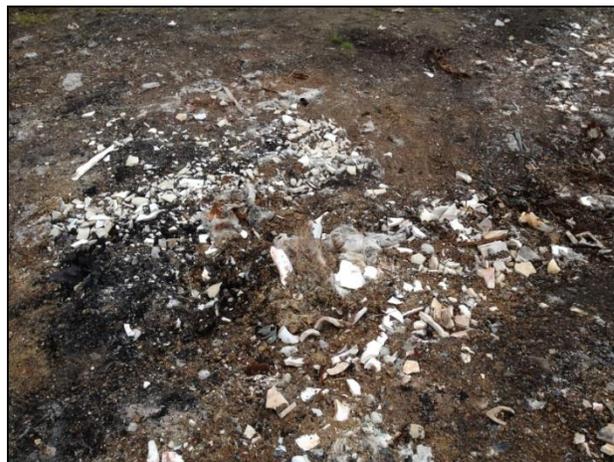
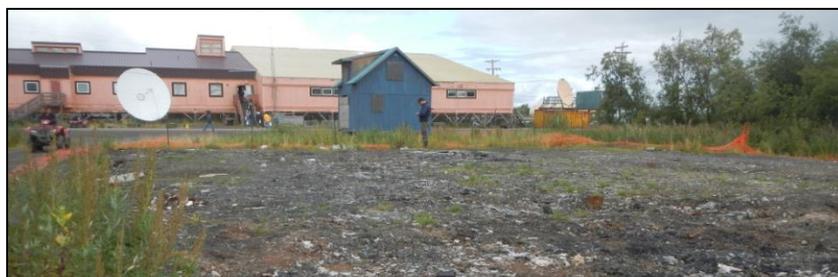
- **Former Joseph Guy Community Center, 60.810074/-161.423644 (Active)** – This community center burned down in April 2006. It is a Brownfield site under the Contaminated Sites Program (File ID 2424.57.001). The material from the burned building was removed and shipped to Bethel in 2012. Only ash was found during the WEAR visit. In 2013 soil samples of the site contained elevated levels of metals. This polluted soil was removed from the site and disposed at the Kwethluk Landfill with Solid Waste Program approval. The site is 418 feet from the Kwethluk River. This section of riverbank is eroding at 2.5 feet a year according to the Army Corps of Engineers 2009 study Alaska Baseline Erosion Assessment (BEA).

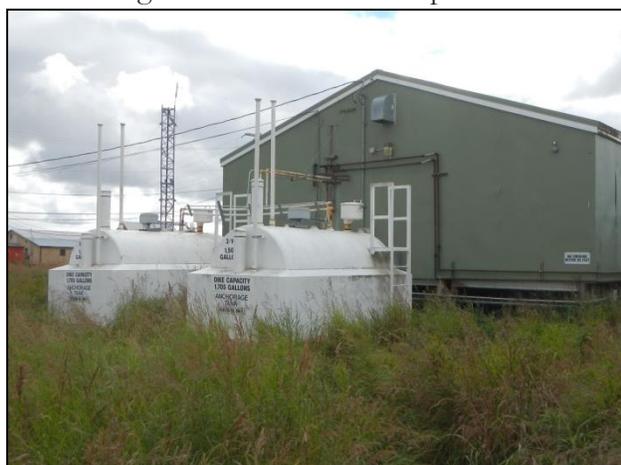
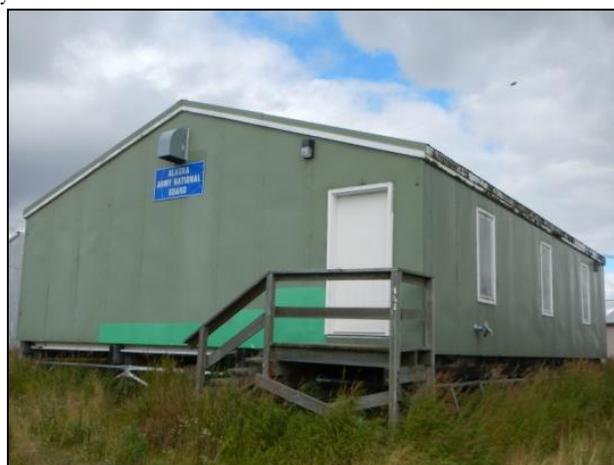
- **AKARNG FSA, 60.810871/-161.435189 (Active)** – This Alaska National Guard Armory is a Contaminated Site (File ID 2424.38.001) due to petroleum contamination dating back to the 1990s. A total of 25 cubic yards of contaminated soil was removed from the site and transported to Bethel for treatment in 2000. Work is ongoing by the Contaminated Sites Program for this site. It is located approximately 360 feet from the Kwethluk River, which is eroding at 2.3 feet in this area per the BEA study.

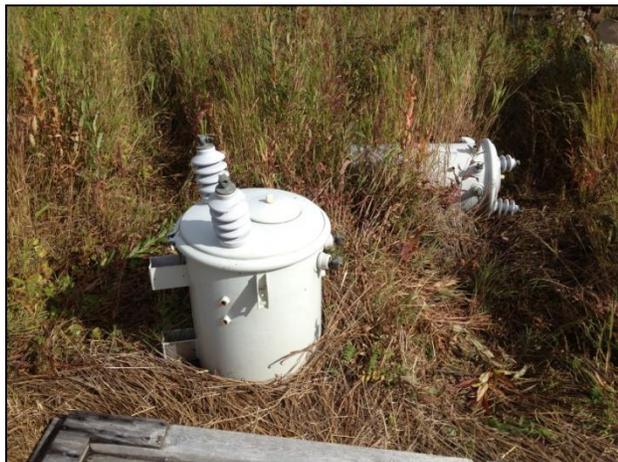
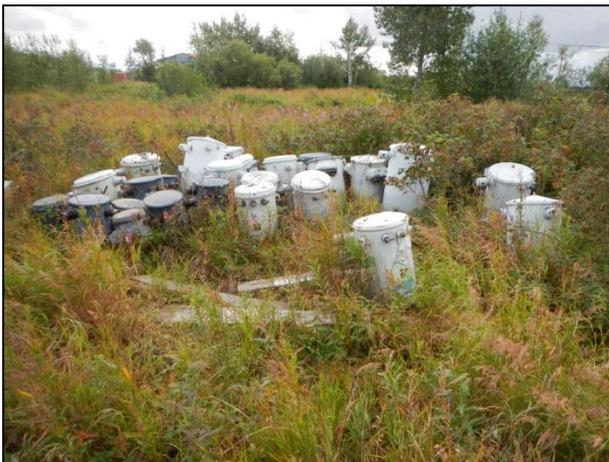
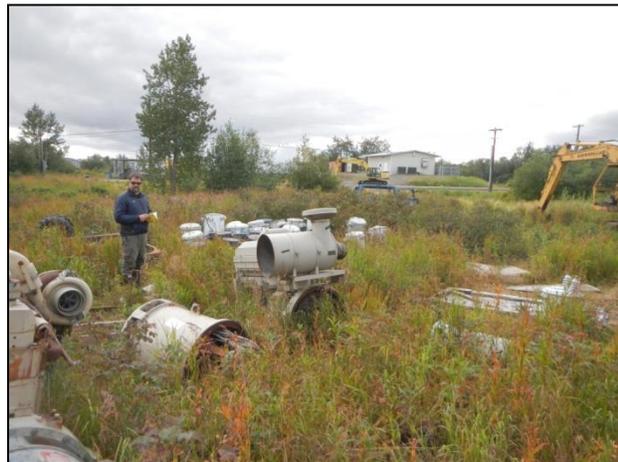
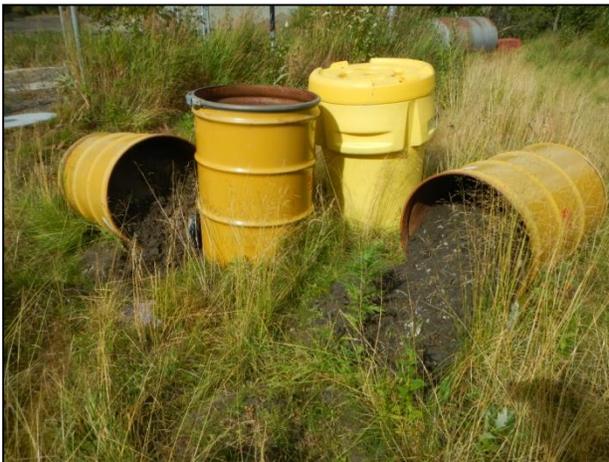
- **Transformer Cache, 60.810902/-161.418393 (Abandoned)** – This site is located across the road from the Bulk Tank Farm. It contained more than 27 used transformers with stressed vegetation in the area. There was also various old equipment scattered throughout the field and several 55 gallon drums with soil open and spilling onto the ground. It is approximately 300 feet from the Kwethluk River, which the BEA study reports as eroding at 2.5 feet a year.

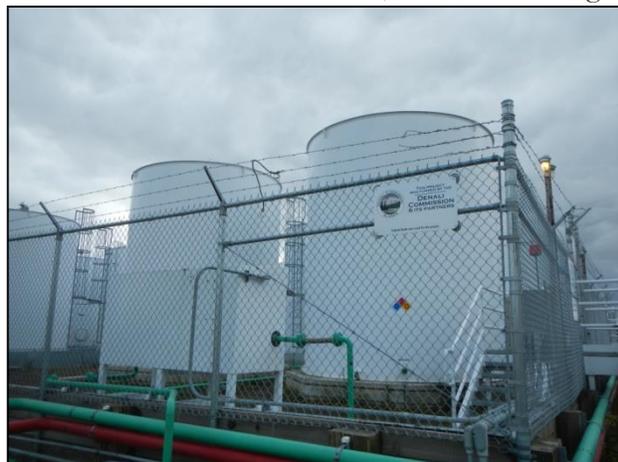
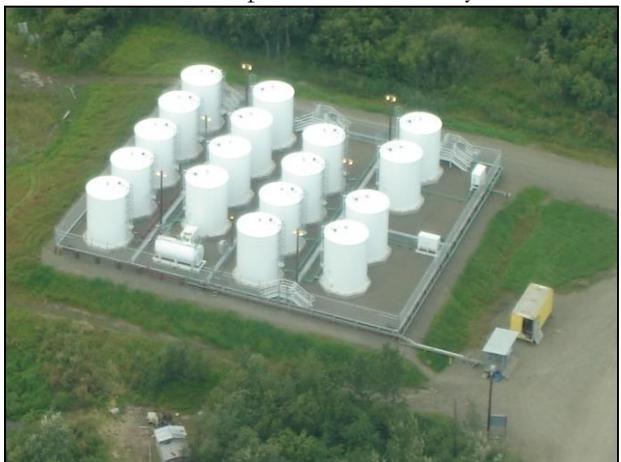
- **Bulk Tank Farm, 60.810192/-161.418826 (Active)** – This tank farm is in a locked, fenced area and has a total storage capacity of 439,500 gallons of fuel. It consists of 17 vertical 23,000 gallon tanks, one 3,500 gallon dual product dispensing tank, and 600 feet of new dual product 4-inch header pipeline. It was completed in 2006 by the Denali Commission. It is located 585 feet from the Kwethluk River, which is eroding at 2.5 feet in this area per the BEA study.

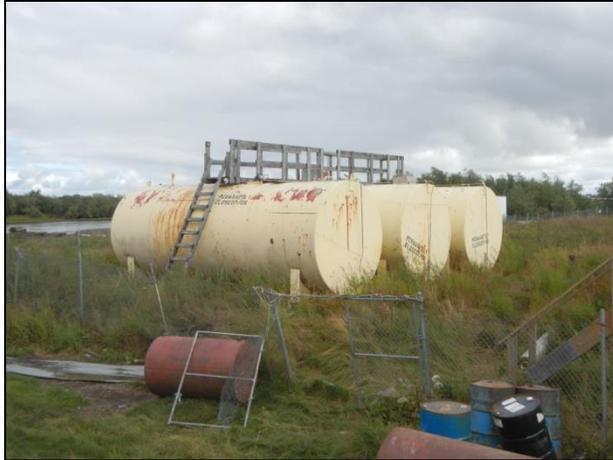
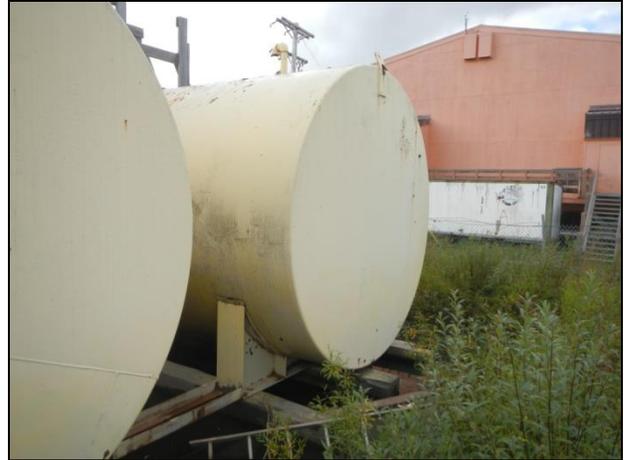
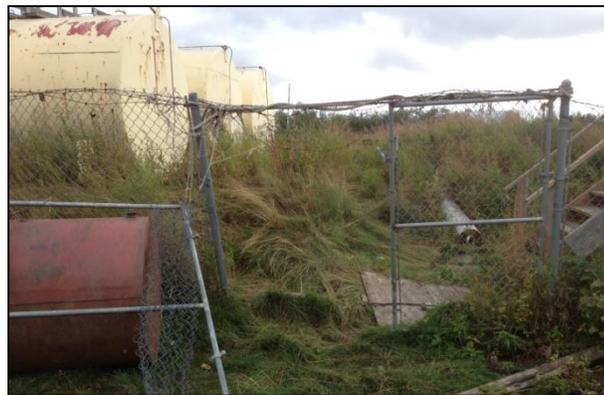
- **School Tank Farm, 60.810747/-161.422583 (Abandoned)** – This tank farm consists of three horizontal fuel tanks on wooden pilings that were marked ‘Permanently Closed 7/06’. It was closed when the Bulk Tank Farm was completed in 2006. The tanks were surrounded by fencing which was falling down and in poor condition. The site was on an earthen berm several feet above ground level with vegetation growing inside the berm. This easily accessible site is 60 feet from the school and next to a main road. It is 170 feet from the Kwethluk River, which is eroding at 2.5 feet in this area per the BEA study.

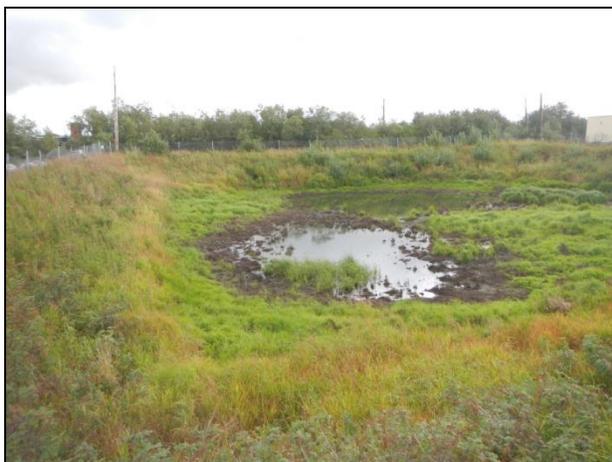
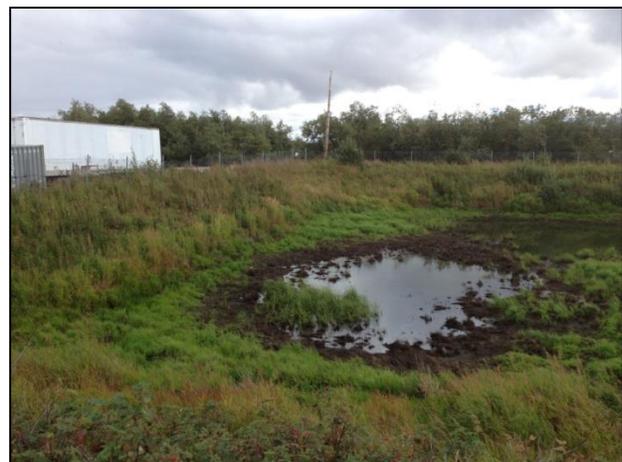
- **School Sewage Lagoon, 60.81067/-161.421682 (Inactive)** – This inactive sewage lagoon is located within the same fence as the Tank Farm at School. It is adjacent to the road as well. It has not been de-watered or covered as required by the Solid Waste Program to close a sewage lagoon. There were no visible signs to notify the public it is a sewage lagoon to stay away. It is 170 feet from the Kwethluk River, which is eroding at 2.5 feet in this area per the BEA study.

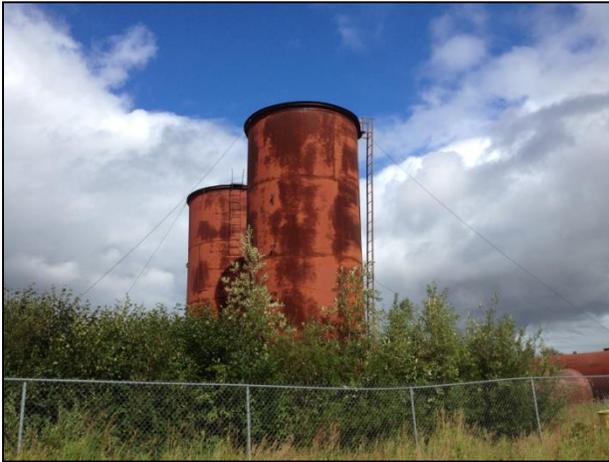
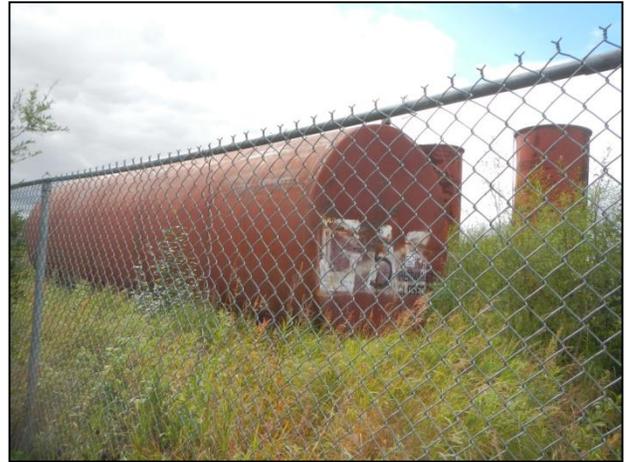
- **Kwethluk Inc. Old Retail Tanks, 60.811047/-161.418319 (Abandoned)** – This former tank farm is owned by Kwethluk Inc. It was closed when the Bulk Tank Farm was completed in 2006. It consists of two vertical and two horizontal fuel tanks in a fenced area. Some of the tanks were marked ‘Permanently Closed 7/06’. The Kwethluk River is eroding at 2.5 feet a year at this section per the BEA study and is 200 feet to the north.

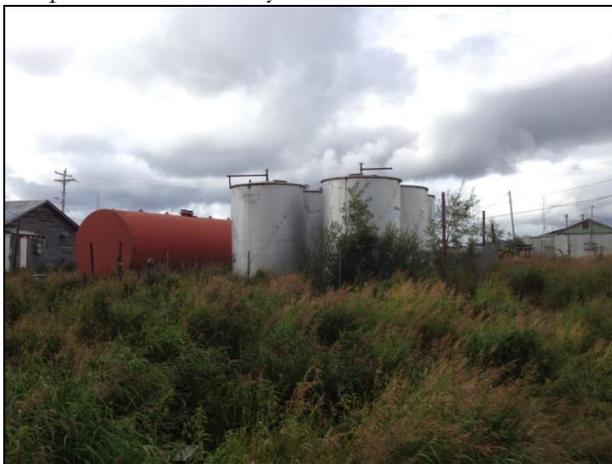
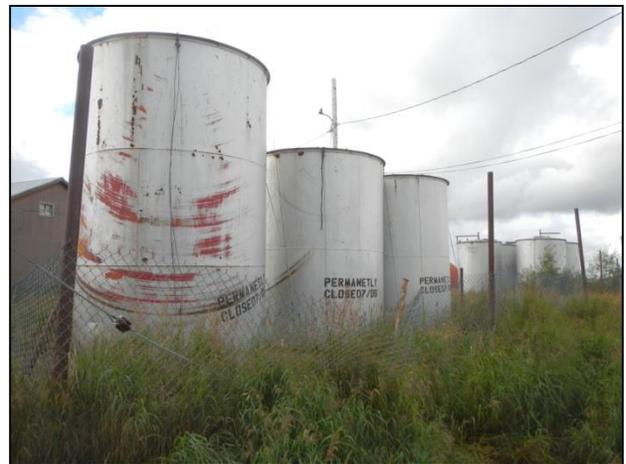
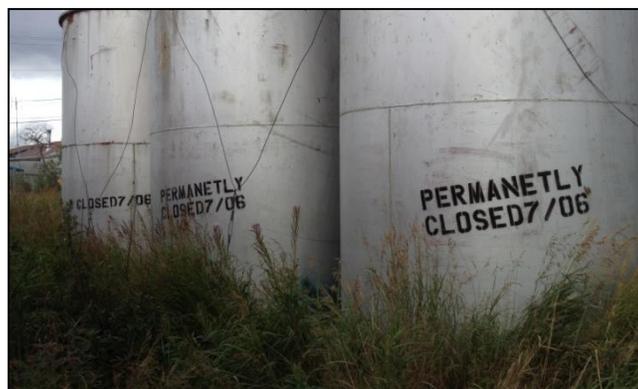
- **Old Tank Farms, 60.811312/-161.434092 (Abandoned)** – These are two small tank farms 50 feet apart. The western tank farm consisted of six vertical tanks and one horizontal tank in a fenced area. The eastern tank farm consisted of three vertical fuel tanks in a fenced area. All 10 tanks were marked ‘Permanently Closed 7/06’. The fences at both sites were in poor condition and falling down in places. Tanks were disconnected and vegetation was growing around them. The Kwethluk River is 130 feet at the closest location. It is eroding at a rate of 2.3 feet a year per the BEA study.
