Alaska Department of Environmental Conservation (ADEC) Solid Waste Program (Trisha Bower and Kym Bronson) conducted a Coastal Impact Assistance Program (CIAP), Waste Erosion Assessment and Review (WEAR) site visit for the City of Barrow, August 27<sup>th</sup>, 2014. The following narrative is a brief description of our findings during the August inspection.

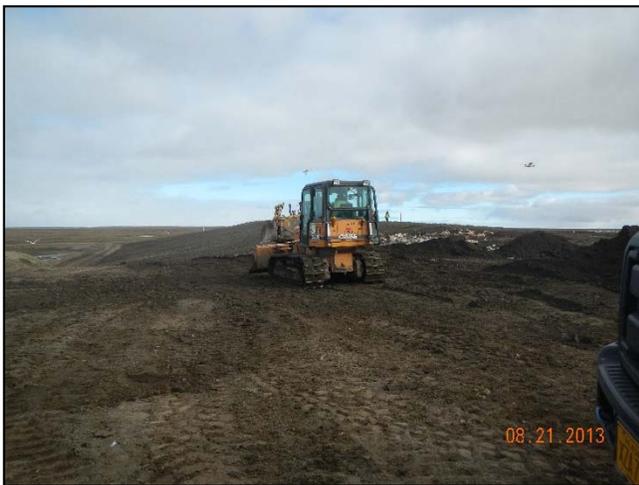
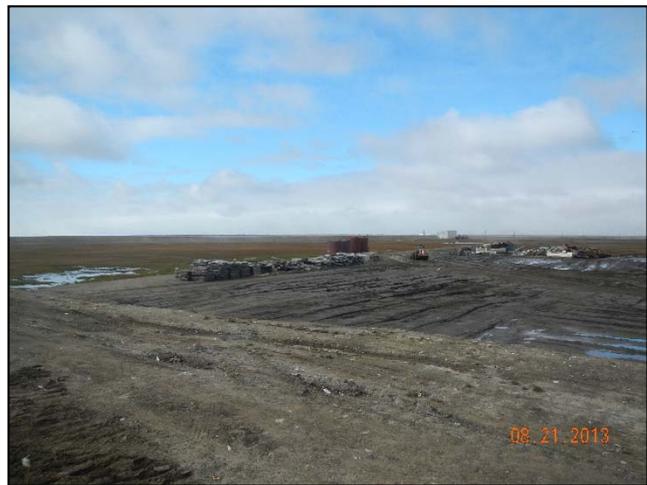
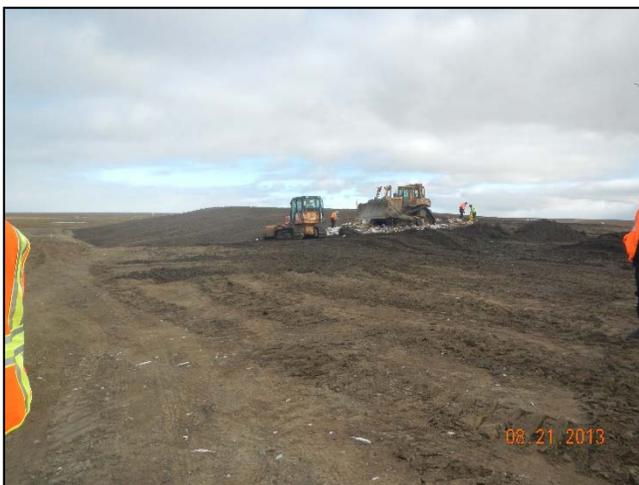
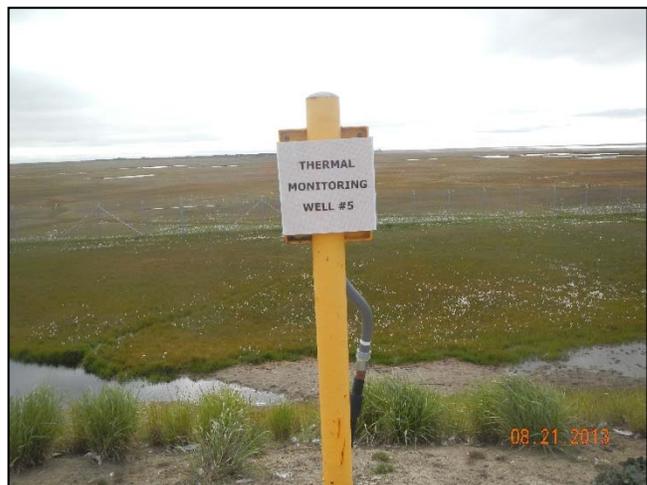
- **Landfill, 71.241865/-156.553563 (Active)** — This 55 acre site is a permitted Class II landfill that is operated by the North Slope Borough. It is located 5.5 miles southeast of the community and has been in operation since 2004. The Borough has a Public Works Department that manages the landfill, employing a full-time Landfill Manager and auxiliary staff. This landfill is designed as a freezeback landfill and is currently monitoring freezeback using thermistors. It accepts municipal solid waste, construction and demolition debris, scrap metal, polluted soil, sewage sludge and some special wastes with ADEC approval. This facility is completely fenced and is located approximately 3.5 miles from Elson Lagoon.

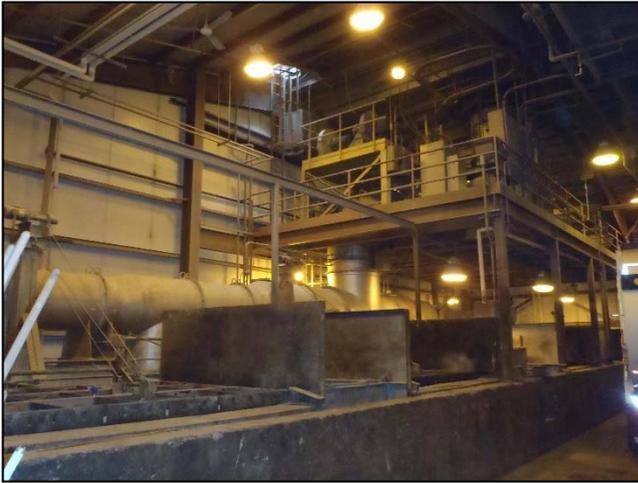
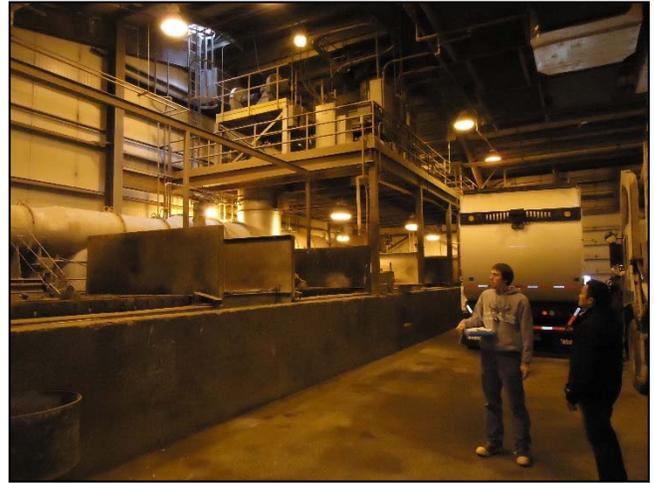
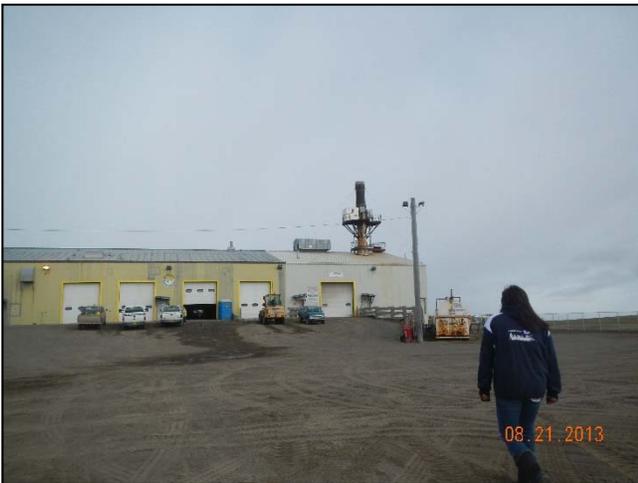
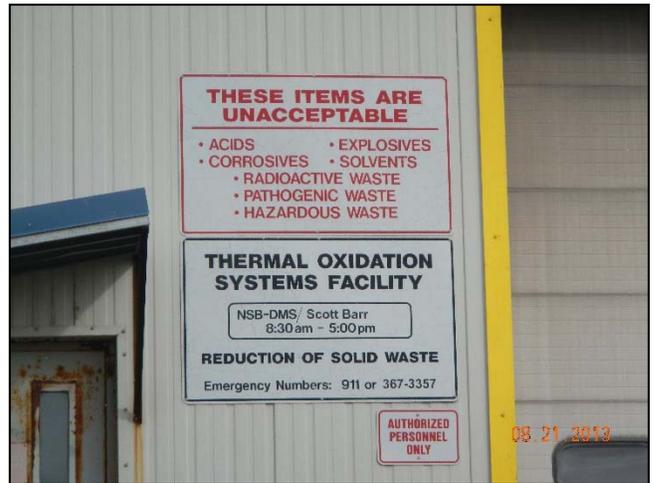
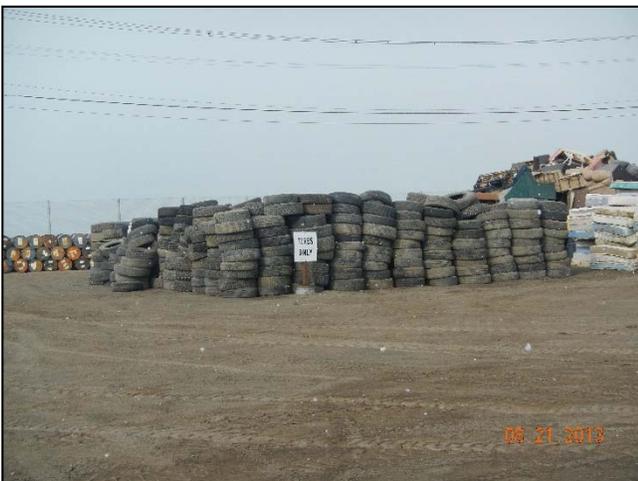
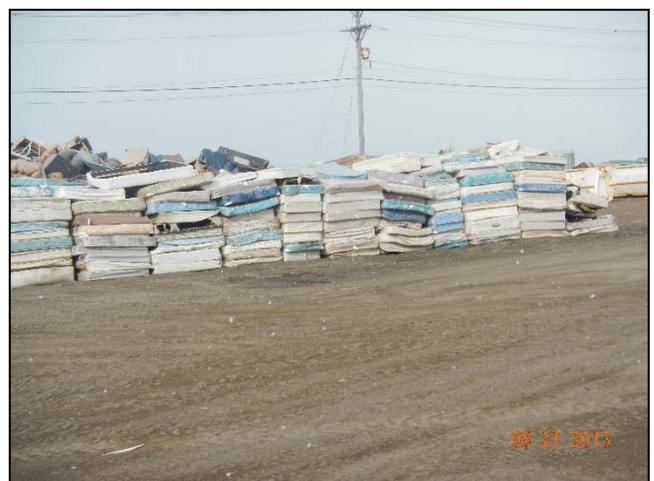
- **TOS Facility, 71.314602/-156.721474 (Inactive)** – Historically the North Slope Borough processed the majority of their waste through the permitted thermal oxidation system (TOS), and disposed of the ash in the Barrow Landfill. This was required due to the landfills close proximity to nesting grounds for an endangered species. It began operations in 2004, but it has been down since 2012. Until it is operational again, all the waste is being disposed of in the landfill without being processed in the TOS unit. The North Slope Borough also collects various materials for recycling and backhaul at this location. This site is located approximately 90 feet from the Chukchi Sea.

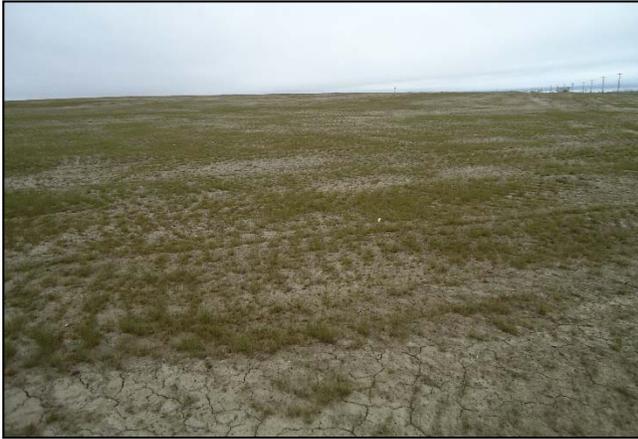
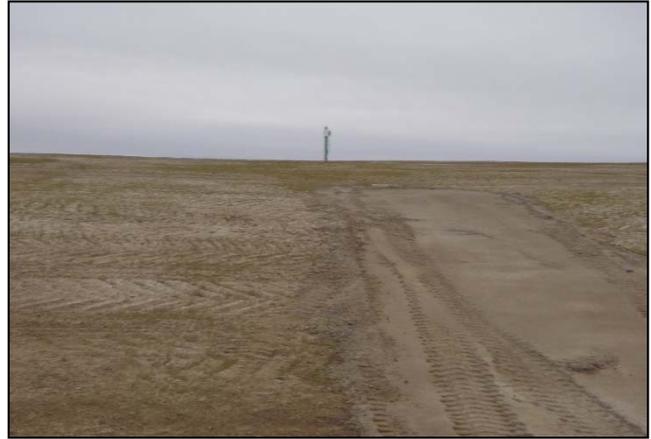
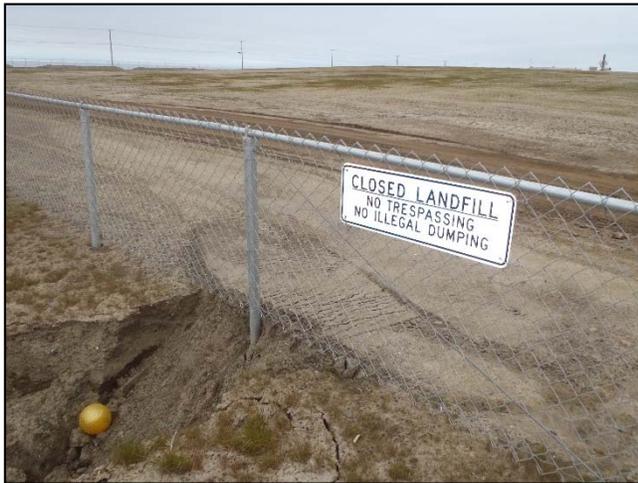
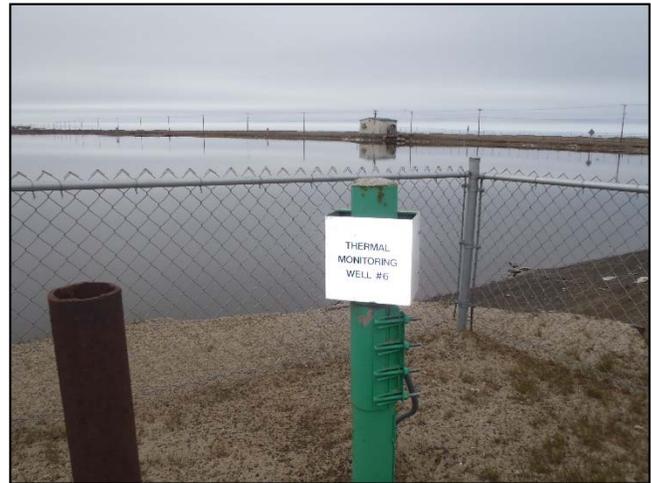
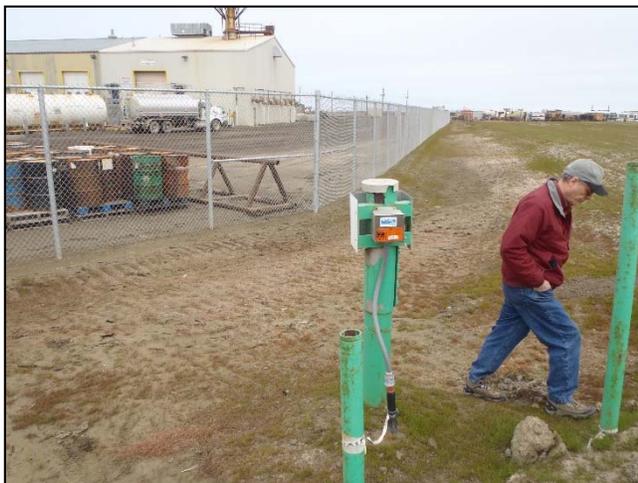
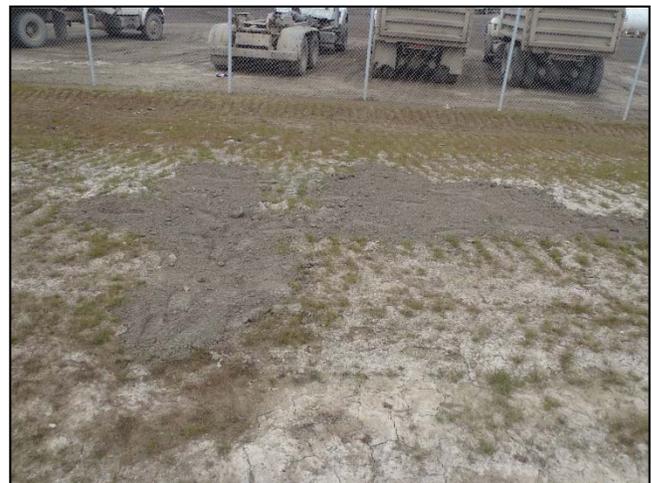
- **Barrow North Salt Lagoon Landfill, 71.313143/-156.722782 (Closed)** — This 40 acre site is a closed Class II landfill that is maintained by the North Slope Borough. It is located 2 miles northeast of the community of Barrow along Stevenson Street and adjacent to the TOS Facility. The landfill was established in 1955 and received wastes until it was closed in 2007. Wastes deposited at the site predominately consisted of municipal solid waste, non-hazardous commercial waste, and construction and demolition debris waste. The landfill was closed using a freezeback design and is currently monitoring freezeback using thermistors. The Borough has a Public Works Department that maintains and monitors the site. The northwestern boundary of the landfill runs parallel to Stevenson Street and is approximately 100 feet from the Chukchi Sea.

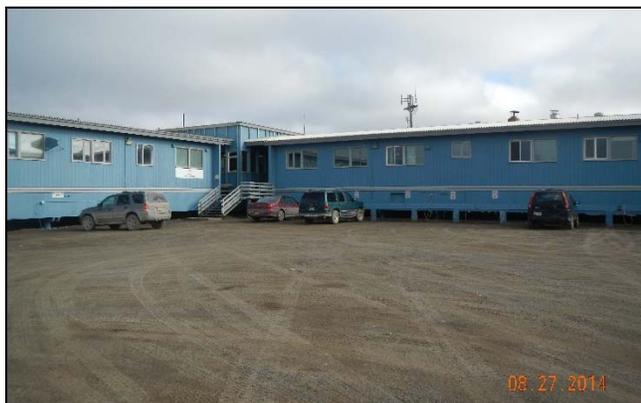
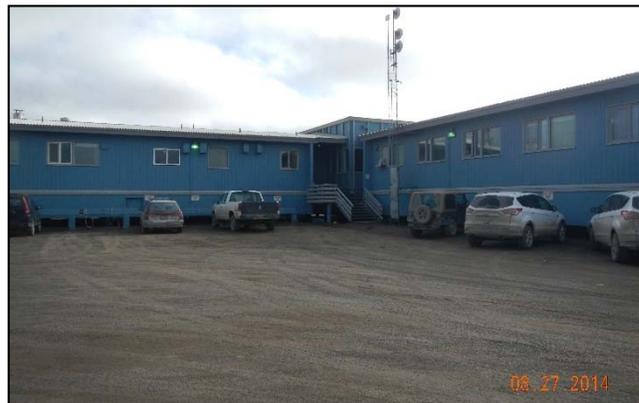
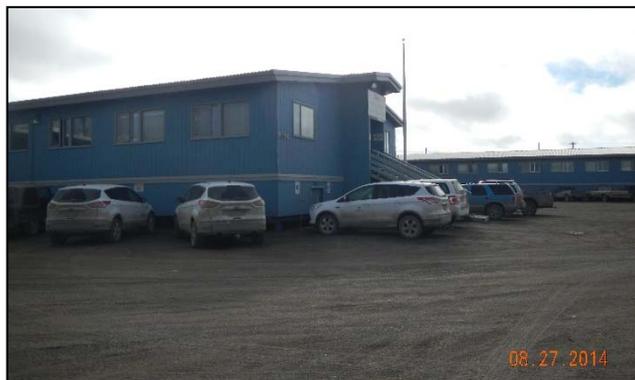
- **NARL – Naval Arctic Research Lab, 71.324892/-156.679144 (Active)** – This site is located almost 2 miles northeast of Barrow. It is a known Contaminated Site (File ID 310.38.008) due to fuel spills of at least 700,000 gallons dating from the 1970s and possible PCB contamination. A minimal amount of fuel was recovered. Seasonal near surface groundwater under gravel near the hangar area has floating hydrocarbons. Imikpuk Lake, a drinking water source, is jeopardized. Extent of contamination remains unknown. Active soil layer from ground surface to about 20-55 inches below ground surface. This site is located approximately 1030 feet from the Chukchi Sea.

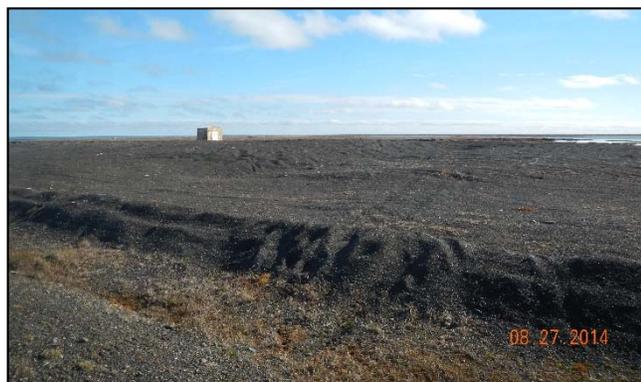
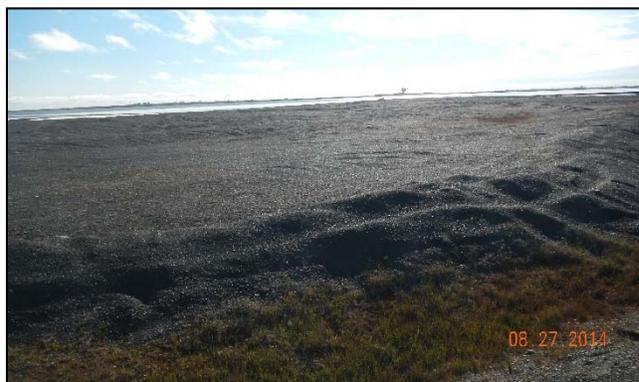
- **NARL Bulk Fuel Tank Farm, 71.342103/-156.609610 (Active)** – This is a known contaminated site that is being monitored by the Contaminated Sites Program (File ID 310.38.016). This is the site of the former bulk fuel tank farm which piped fuel to the Naval Arctic Research Laboratory (NARL) facility. There was 100,000 gallons of jet fuel spilled in 1970 and there is no record of cleanup activities. The tanks have long been removed and the site is a large gravel pad by the North Salt Lagoon. Soil cleanup activities were conducted in 2003 and the site remains under long-term monitoring with annual sampling. This site is located approximately 1220 feet from the Chukchi Sea.

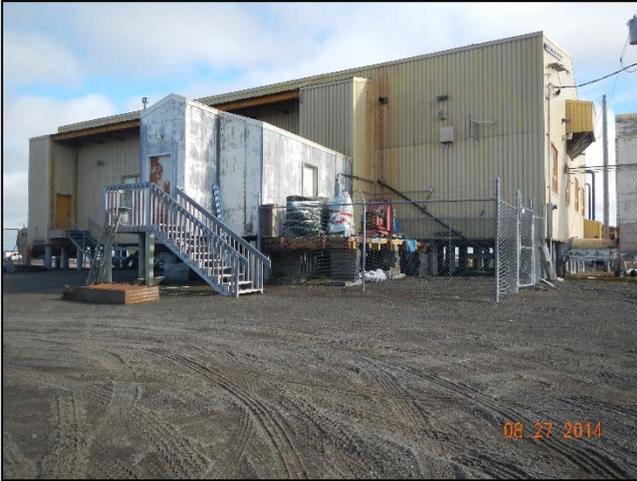
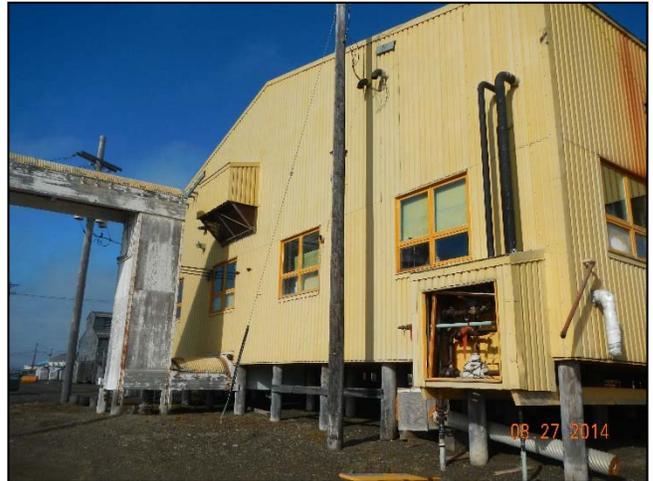
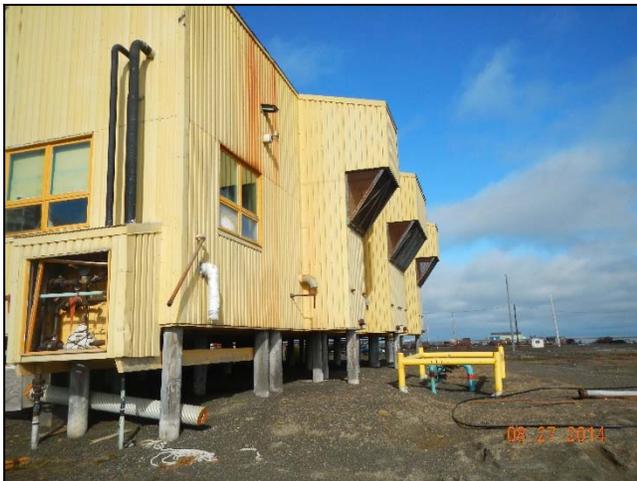
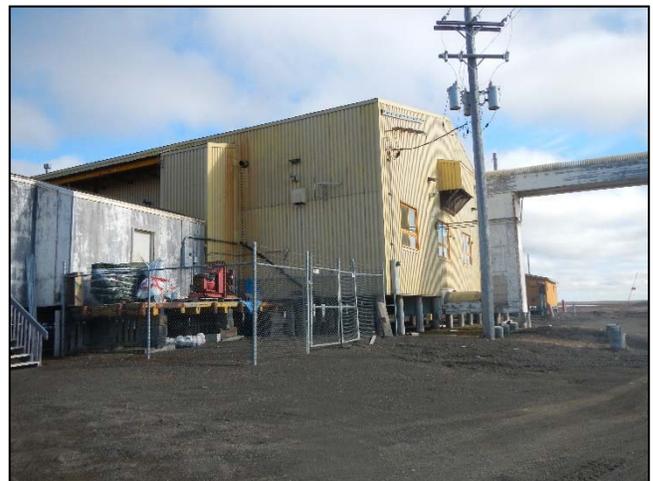
- **NARL Powerhouse Fuel Spill, 71.327565/-156.670721 (Active)** – This is an active Contaminated Site (File ID 410.26.007) due to petroleum contamination. Reportedly a 10,000 gallon fuel spill occurred at the site in 1958. This site is under long-term monitoring of soil and water sampling on a yearly basis. This site is located approximately 960 feet from the Chukchi Sea.

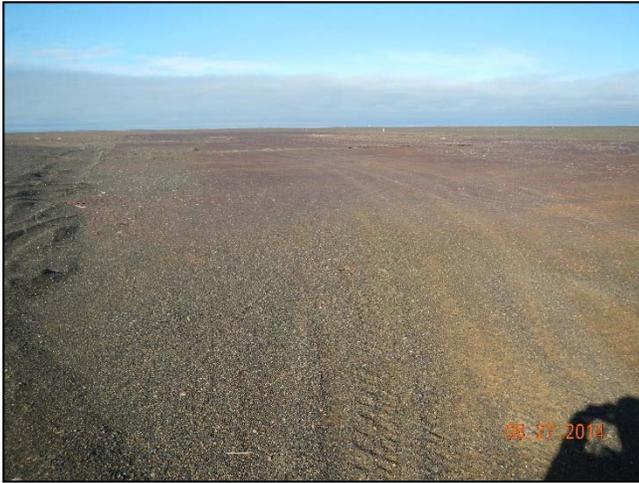
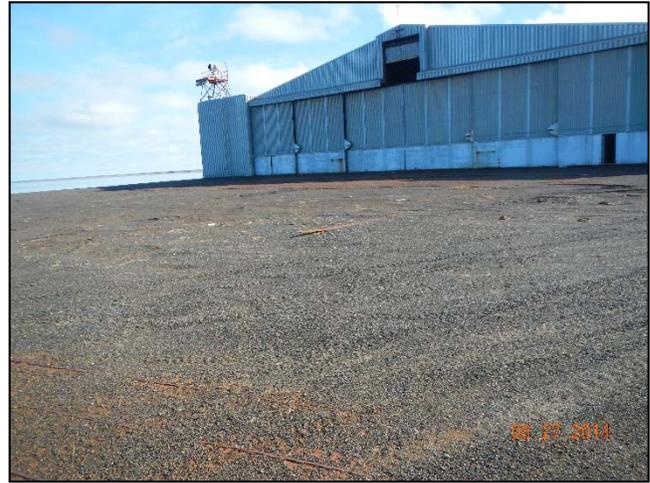
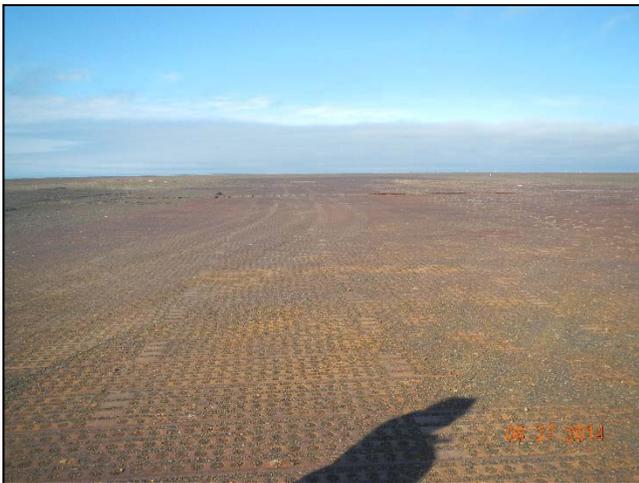
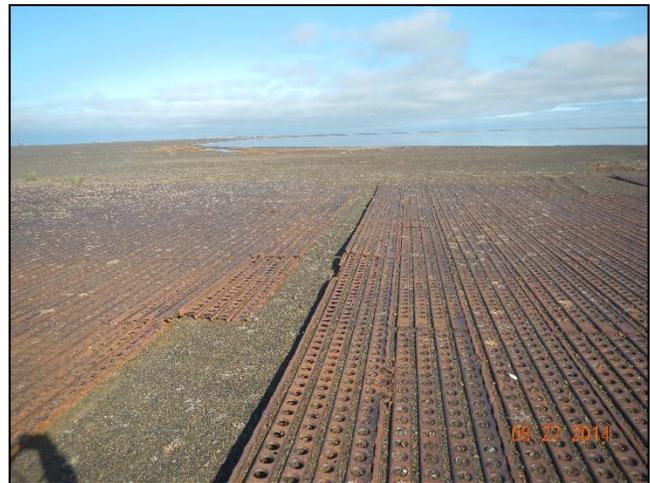
- **NARL Airstrip Fuel Spill, 71.335965/-156.645617 (Active)** – This is a known Contaminated Site (File ID 310.38.012) due to several fuel spills from various locations at this site, primarily confined to the hangar area. Spills are: 1976 - estimated 48,000 gallons of gasoline; 1978 - 24,700 gallons of jet fuel and 277,463 gallons of gasoline (140,000 gallons recovered); and 1986 - unknown quantity of jet fuel. The Naval Arctic Research Laboratory (NARL) airstrip, which is located northeast of the main NARL complex, was completed in the late 1940s. Several cleanup activities have taken place over the years. The site remains under long-term monitoring with annual sampling and site evaluation every 5 years. This site is located approximately 360 feet from the Chukchi Sea.

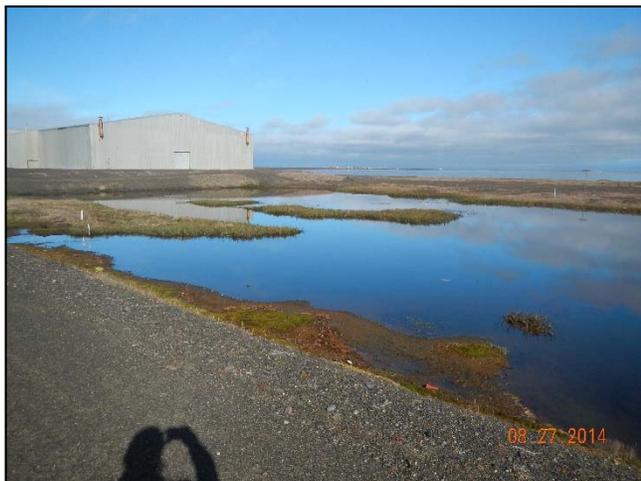
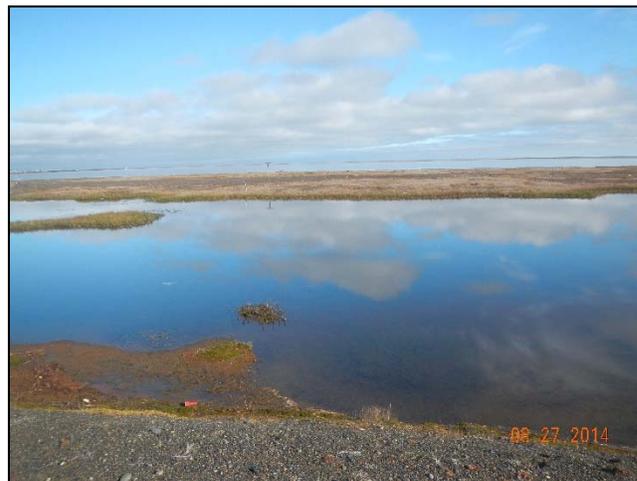
- **Point Barrow POW-M Dewline Site Air Terminal Area, 71.334091/-156.644531 (Active)** – This is a known Contaminated Site (File ID 310.38.004). The Air Terminal Area is located north of the main installation on the western shore of the North Salt Lagoon. Data collected during the 2007 Remedial Investigation indicated volatile petroleum hydrocarbons were present in surface soil, surface water of a tundra pond, and in active layer water. No soil contaminants exceeded appropriate cleanup levels. No documented spills have occurred at the Air Terminal Area. The source of contamination is believed to be multiple large historic fuel spills located up-gradient on the adjacent United States Navy (USN) property at the Barrow Naval Arctic Research Laboratory (NARL) Airstrip Site. The dominant form of contaminant transport appears to occur in the form of dissolved petroleum hydrocarbons moving in the saturated zone above the permafrost. Multiple soil removal actions, product recovery activities, and investigations have been conducted on the up-gradient NARL Airstrip Site on the USN property. The USN is conducting long-term monitoring of the contaminant sources on their property; it is likely to take a number of decades for remaining contamination at the USN site to attenuate sufficiently to allow unrestricted use. Annual inspections are performed at this site as part of the long-term monitoring. This site is located approximately 1200 feet from the Chukchi Sea.

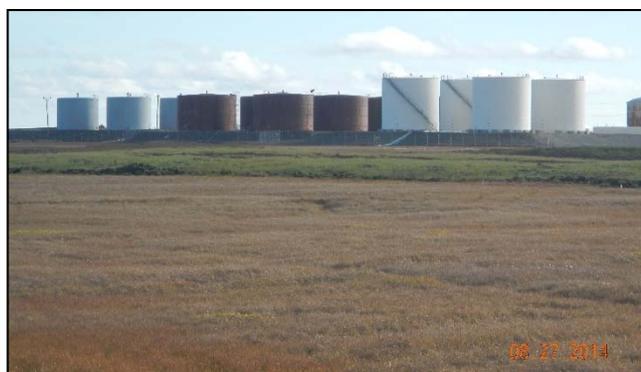
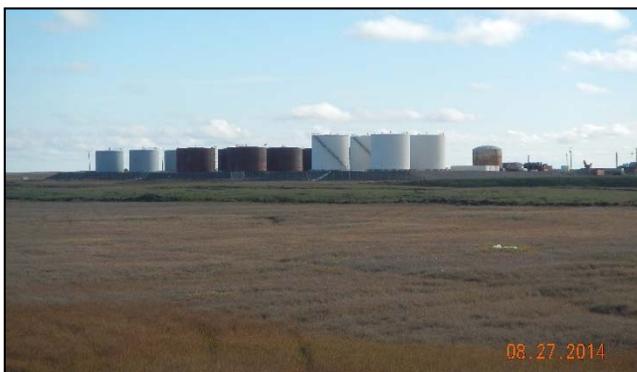
- **Tank Farms, 71.278519/-156.796665 (Active)** – This site consists of two separate tank farms that are located adjacent to each other. One is owned and operated by the North Slope Borough with a total capacity of 1,141,392 gallons. The other tank farm is owned and operated by Eskimos Inc. as the Block B Tank Farm. It has a total capacity of 4,643,983 gallons. Both tank farms are regulated by the ADEC Terminals and Tank Farms Section. There are 17 fuel tanks within separate secured areas with secondary containment. This site is located approximately 2300 feet from the Chukchi Sea.

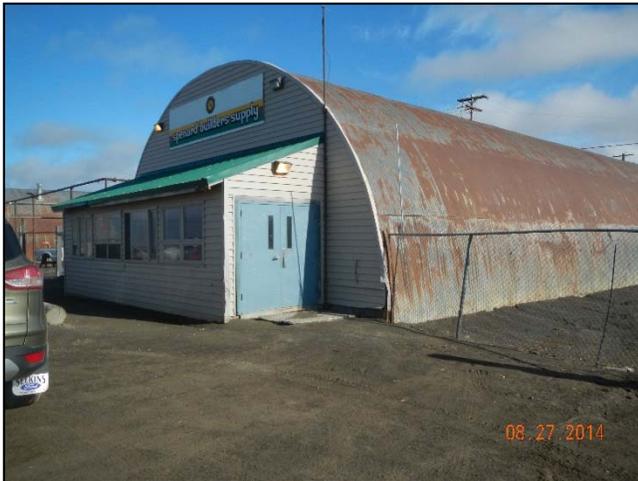
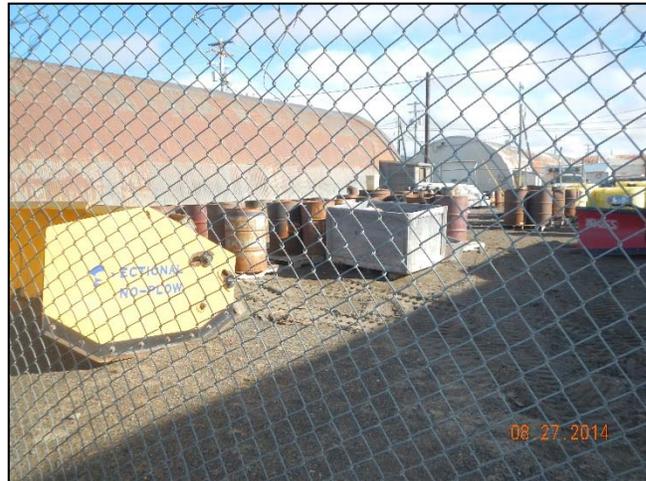
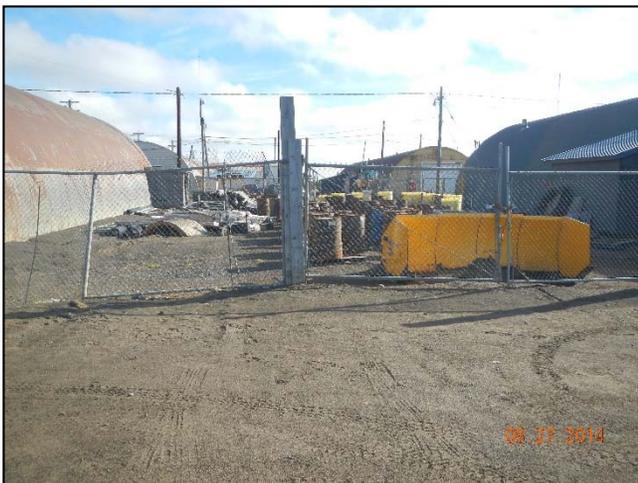
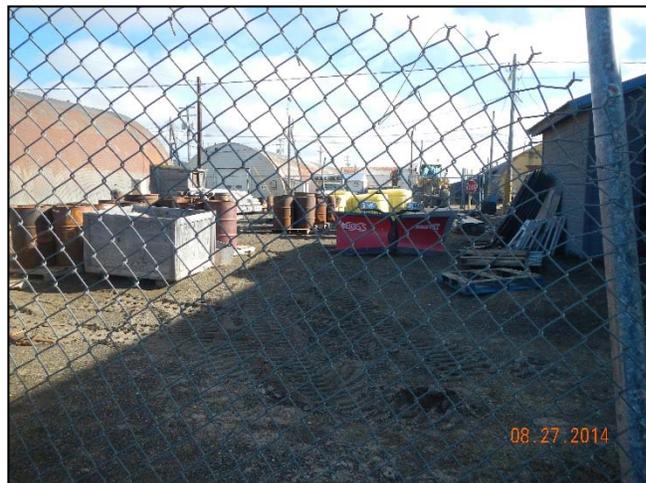
- **Spenard Builders Supply, 71.329356/-156.671685 (Closed)** – This is a known Contaminated Site (File ID 310.38.025) due to a fuel spill. In 2008 approximately 100-150 gallons of gasoline were released to the ground when snow beneath a 300-gallon aboveground storage tank thawed. Initial remediation efforts included excavation to a depth of 3-4 feet, transport of contaminated soil to the Barrow Landfill for treatment, and backfill with clean material. Sampling was conducted later in 2008 after the source area was re-excavated to the bottom of the original excavation. The site status was changed to ‘Cleanup Complete – Institutional Controls’ in 2009. Residual contamination remains at the site, but it does not pose an unacceptable risk to human health or the environment with the institutional controls. This site is located approximately 380 feet from the Chukchi Sea.

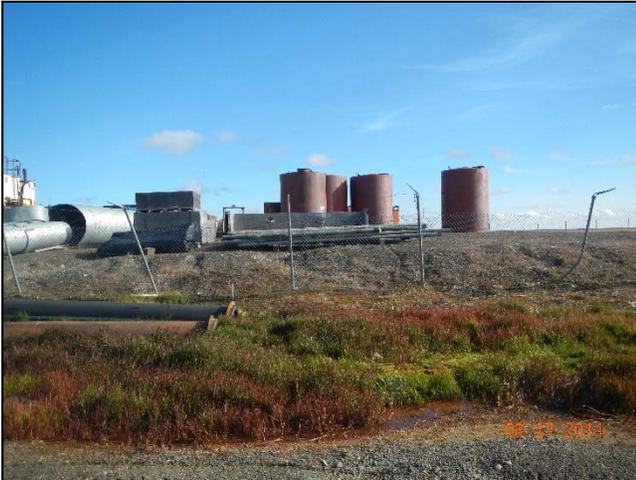
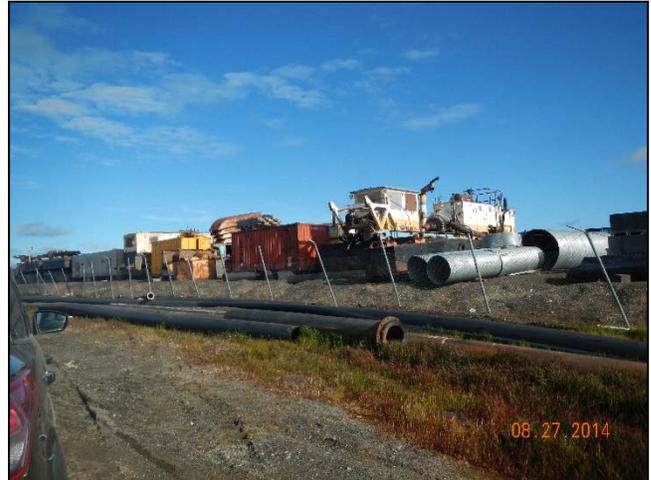
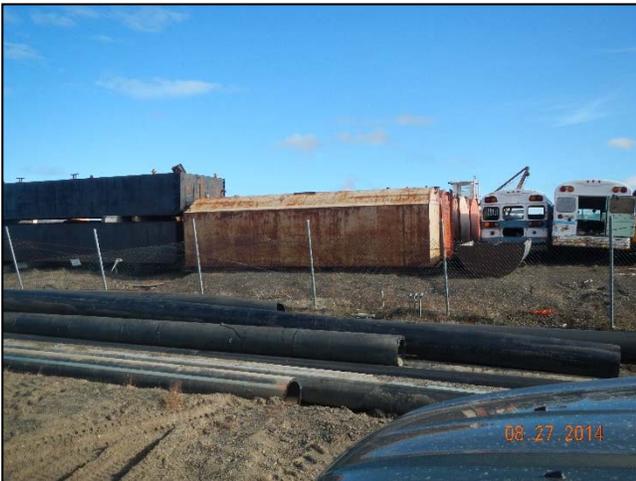
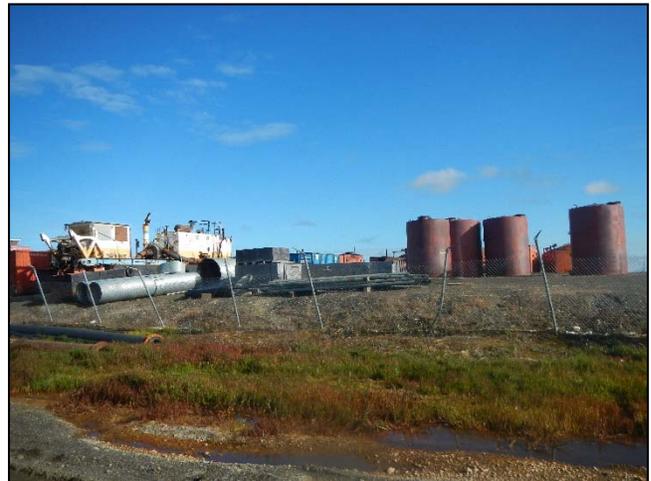
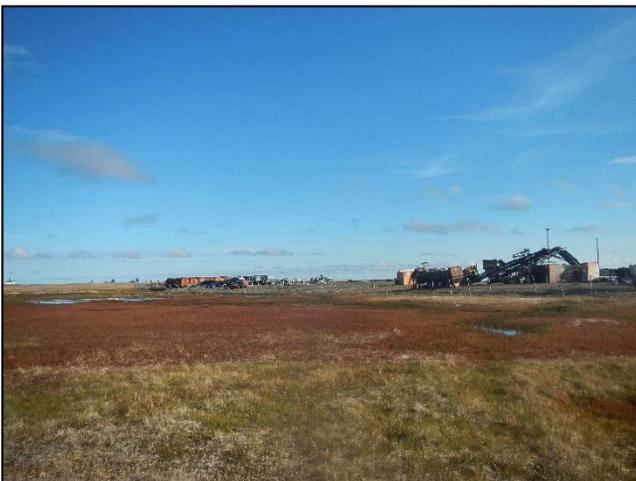
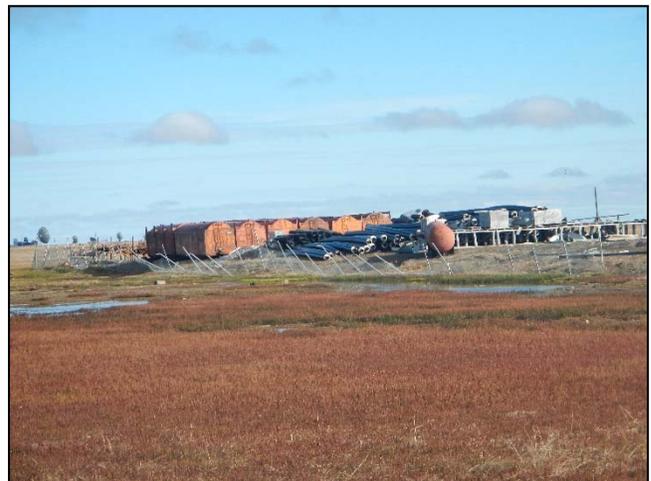
- **NSB South Pad, 71.272685/-156.811367 (Active)** – This 17 acre site is a known Contaminated Site (File ID 310.38.028) that is located approximately 1 mile south of the runway. An inspection conducted in 2011 noted over 350 leaking and/or rusted drums of unknown material, 24 fuel tanks, numerous 5- and 1-gallon containers, stained soil, and signs of contaminant migration from the pad into the surrounding tundra. Characterization of the drums and fuel tanks was conducted in 2013. Further site characterization is on-going for this site. It is located approximately 2000 feet from the Chukchi Sea.
