Alaska Department of Environmental Conservation (ADEC) Solid Waste Program (Kitrina Persson and Elizabeth Stergiou) conducted a Coastal Impact Assistance Program (CIAP), Waste Erosion Assessment and Review (WEAR) site visit for the Village of Egegik, July 31st, 2012. Don Strand, City Administrator, helped coordinate our visit. The following narrative is a brief description of our findings during the July inspection.

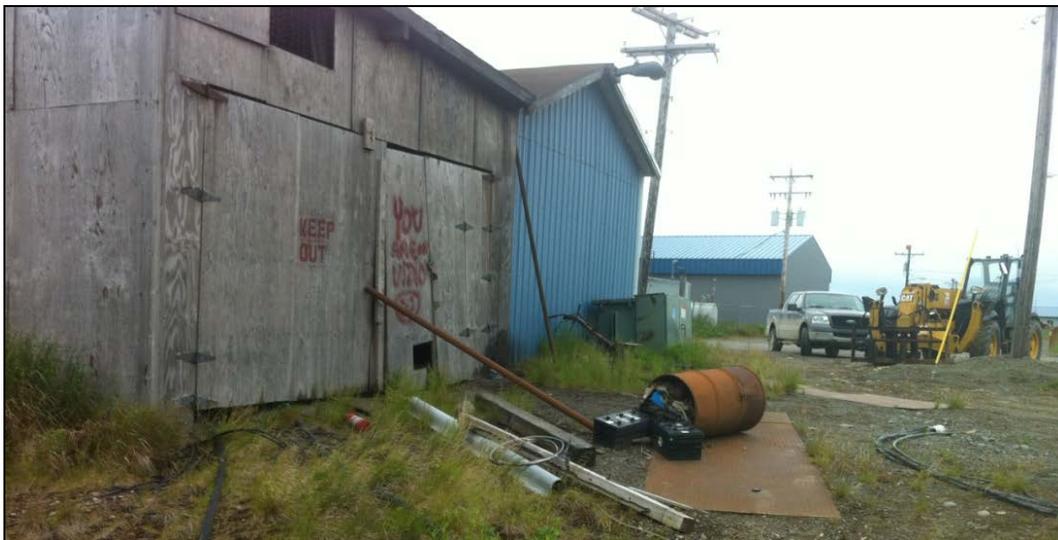
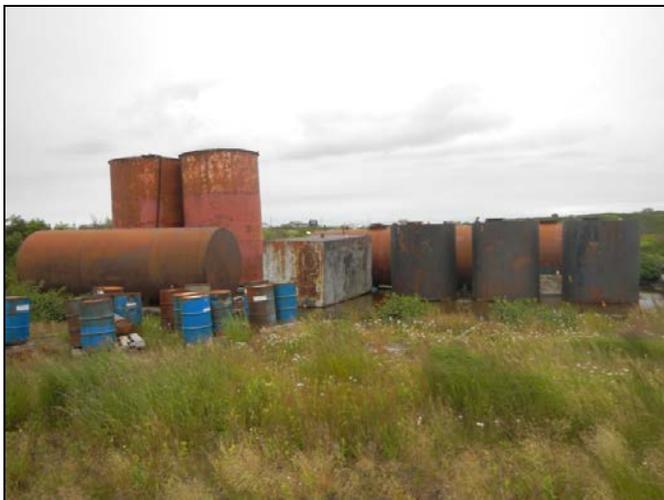
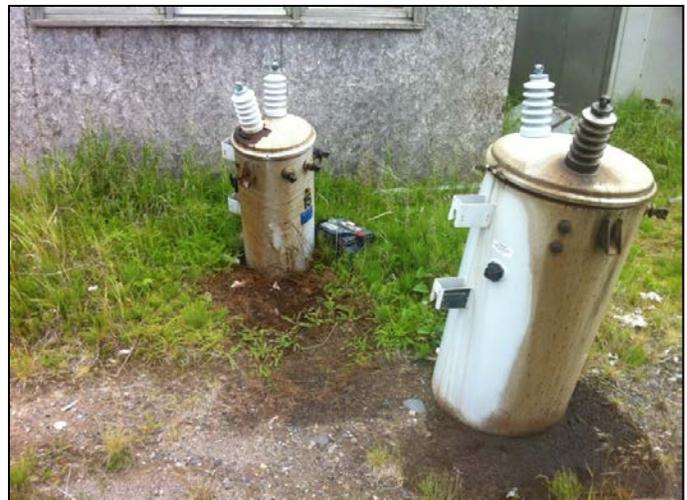
- **Light and Power Facility, 58.212361/-157.374618 (Active)** – The former Egegik Light and Power facility is an active Contaminated Site (File ID 2543.38.001). The site consists of several horizontal and vertical tanks, 55 gallon drums, leaking transformers, batteries, and several sites of spilled petroleum outside the building. Inside the building is the old community generator and associated operations equipment. The area appears to have been vandalized inside and out. The floor of the building is plywood and gravel and is heavily stained. There is a strong petroleum odor. This site is approximately 750 feet from the eroding shoreline of Egegik River and approximately 200 feet from School Lake.

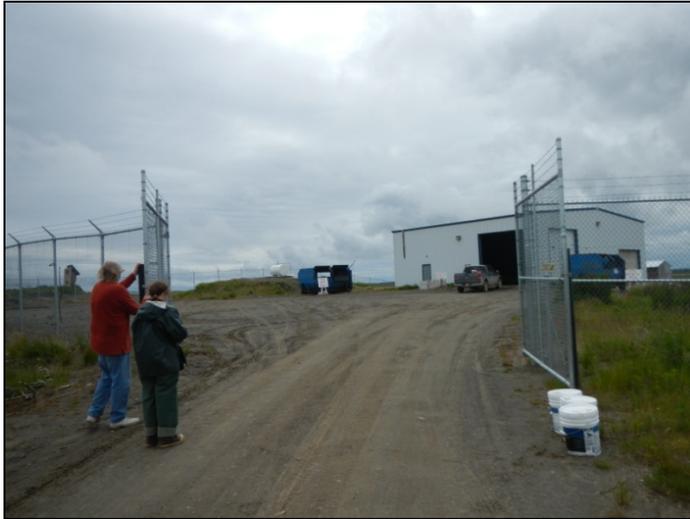
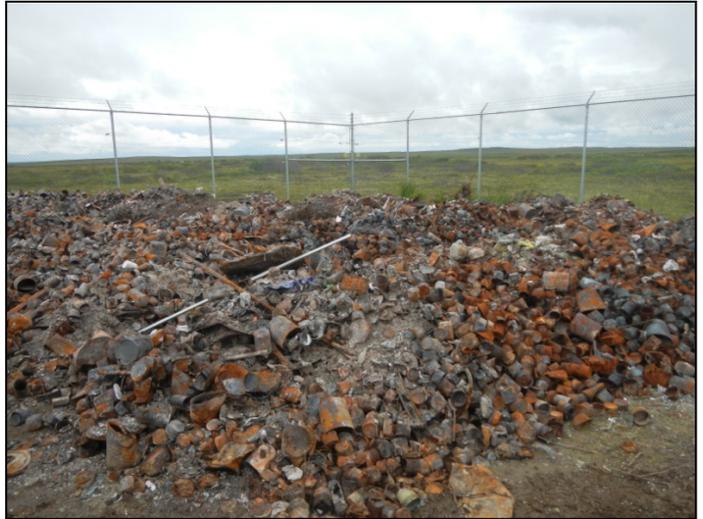
- **Incinerator Building, 58.19468/-157.355579 (Active)** – The incinerator building is the waste processing area for the community of Egegik and the seasonal residents and travelers associated with the commercial fishing industry. It is located at a closed landfill site over 5,000 feet southeast of Egegik River. The community deposits waste in dumpsters at the building. Items that cannot be incinerated are separated from general household waste. City employees monitor the facility and operate the incinerator. Incinerated waste is stored behind the building and moved to the landfill on a yearly basis.

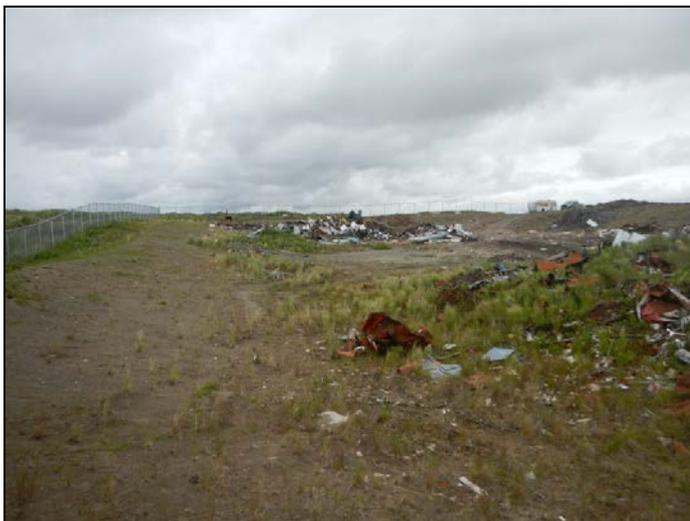
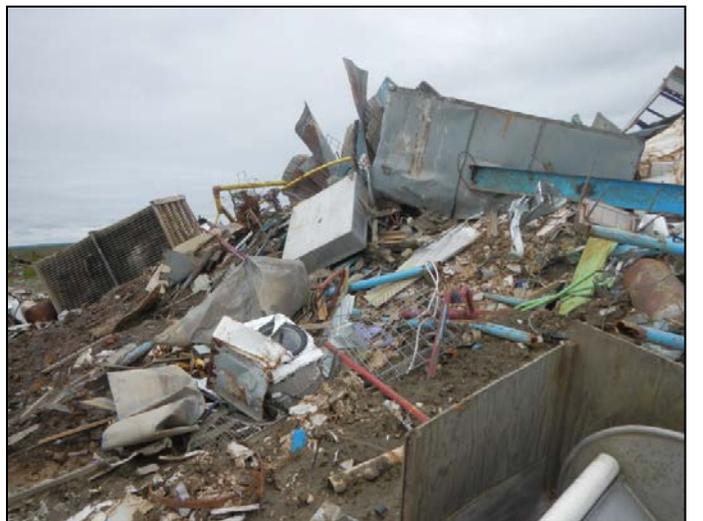
- **Landfill, 58.166429/-157.324915 (Active)** – The landfill is a fenced and locked facility located approximately 15,000 feet southeast of Egegik River at the end of Chifies Road. Waste that cannot be incinerated is deposited here and covered with local soil material intermittently. The majority of waste includes bulky metals from the community and the fish processing plants in Egegik. Ash from the incinerator is moved from behind the incinerator building and deposited in the landfill yearly. Public access for salvaging is not allowed.

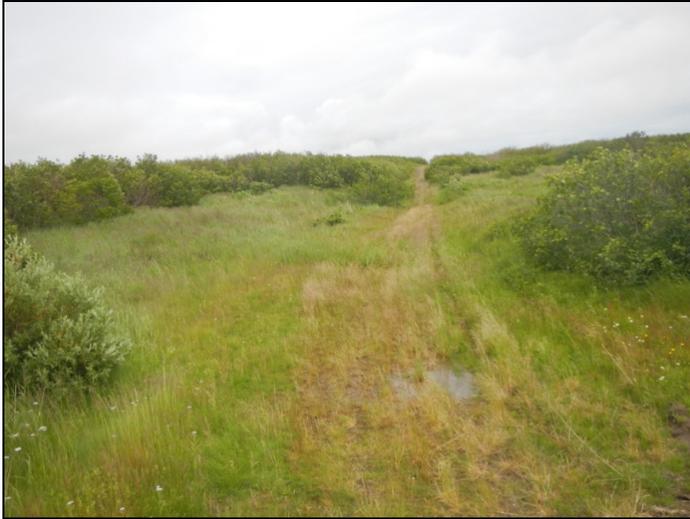
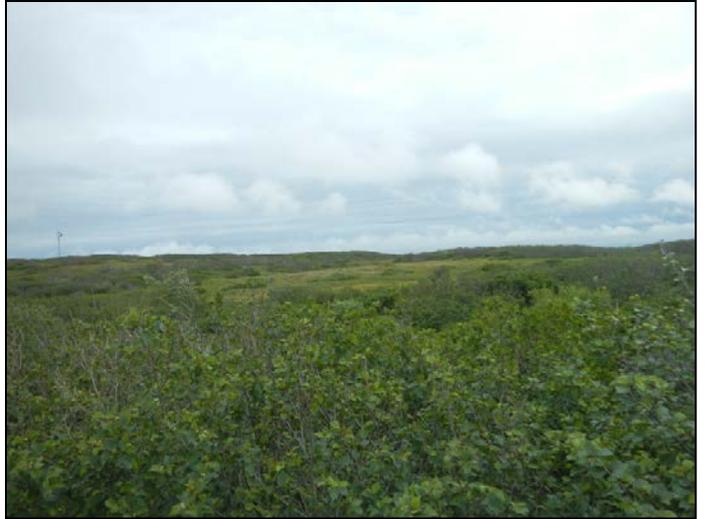
- **Old Landfill Hill, 58.199083/-157.364941 (Closed)** – This previous landfill site is approximately 9,000 feet from Egegik River. A community member recalled a vehicle disposed of in the area, but we did not observe any waste at this site. The area is overgrown with alders and we were not able to explore the area in depth due to high brush and bear activity.

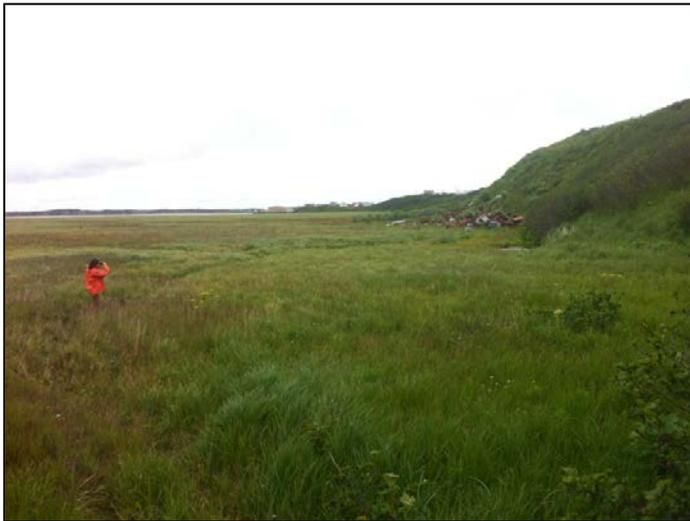
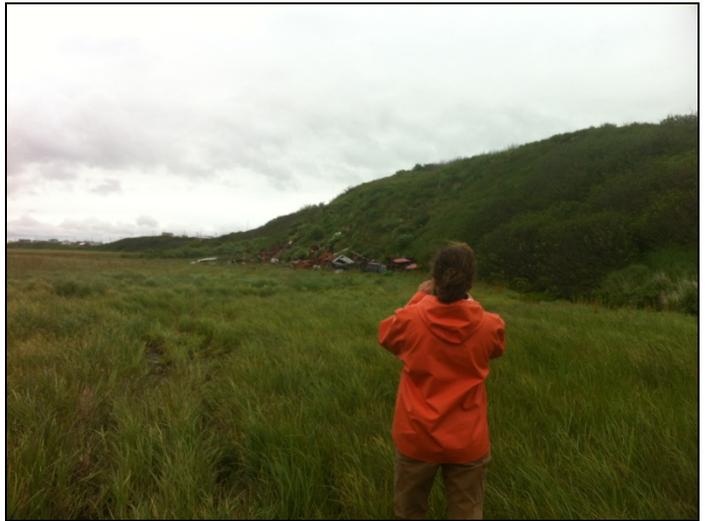
- **Old Shoreline Landfill, 58.204052/-157.379478 (Closed)** – This historical dump site consists of a large pile of metals located at the bottom of a bluff in the Egegik River flood plain. The area was not accessible due to the wetland extending 1,600 feet from the bottom of the bluff to the edge of the Egegik River.

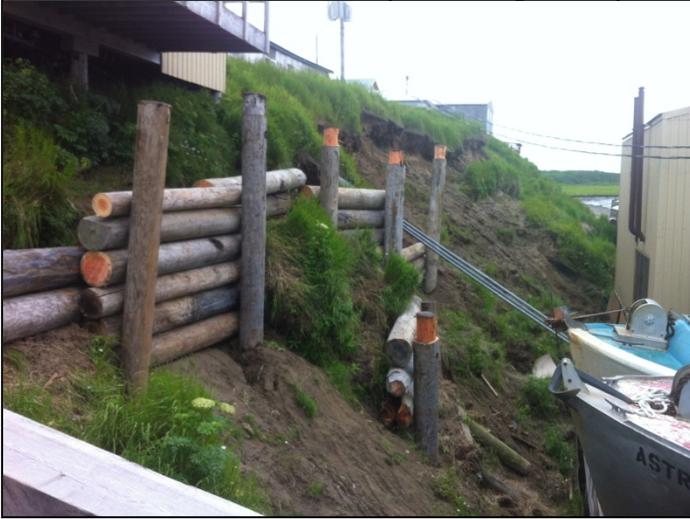
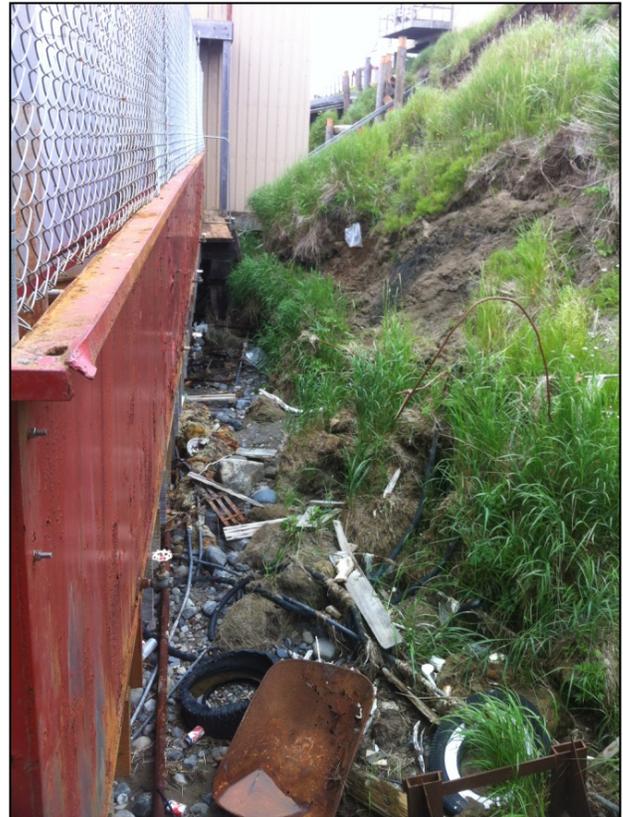
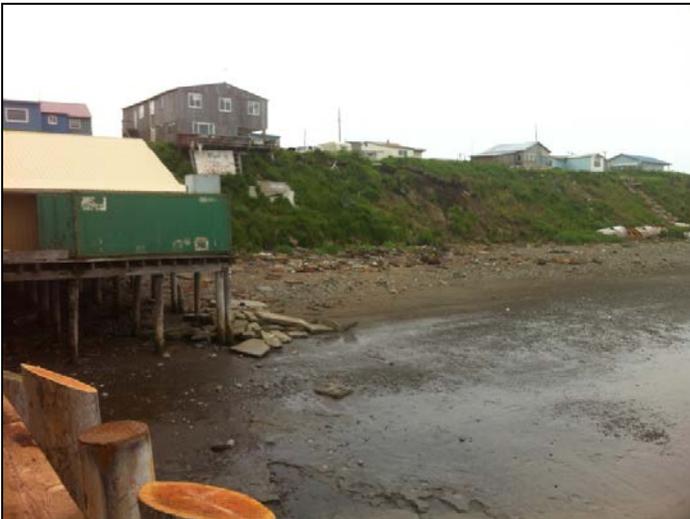
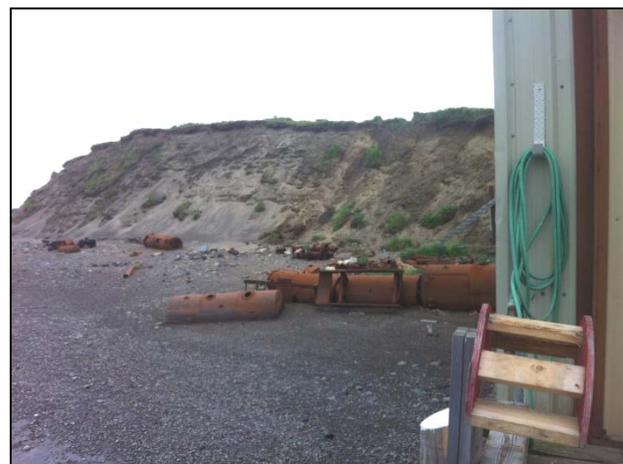
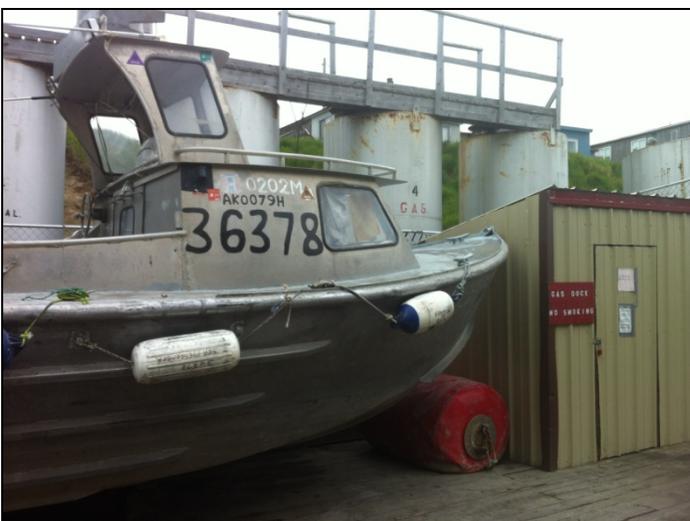
- **Alaska General Seafoods Fish Plant, 58.214182/-157.378982 (Active)** – This plant is located at the mouth of Egegik River. Waste was observed collected at the high tide line under the dock. There are multiple fuel tanks on site. The 20-foot bluff is eroding to the north and south of the processing plant. Log structures have been built on the bluff behind the dock in an attempt to slow erosion. Several fuel tanks and other debris has been placed on the beach to the north and south of the dock in an attempt to slow erosion, however, the effort is not reported to be effective. The soil is sandy and sloughs easily during high wind, waves and precipitation.

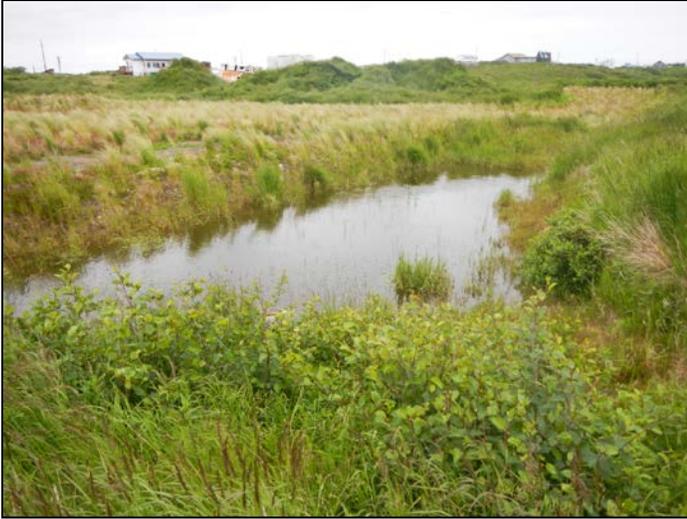
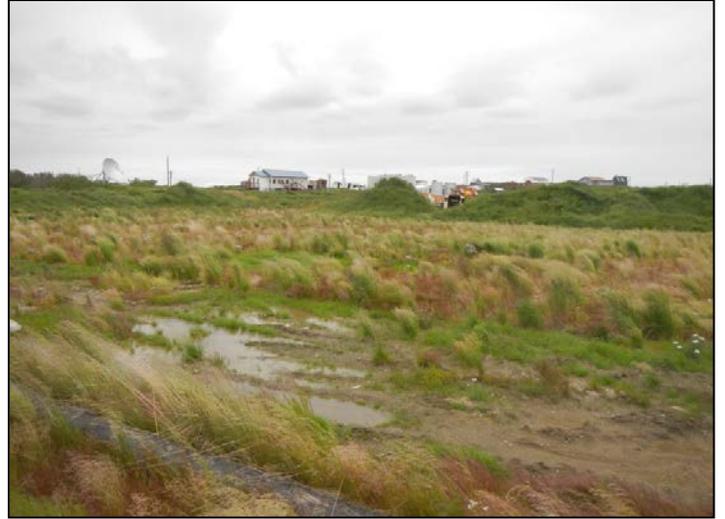
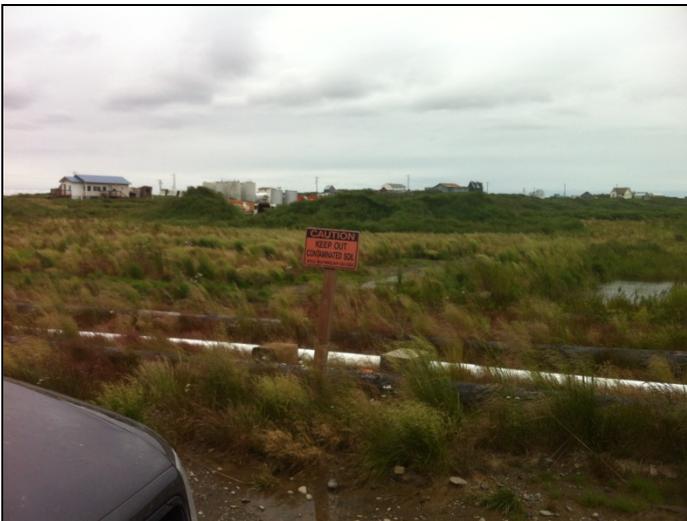
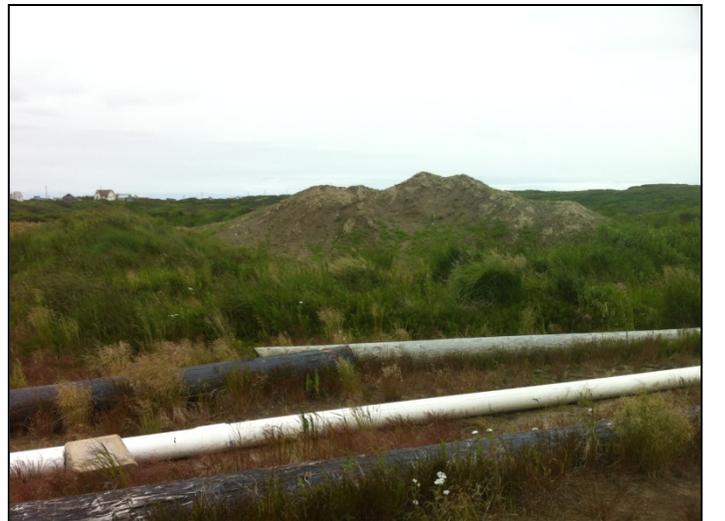
- **Icicle Seafoods Contaminated Soil, 58.212975/-157.37341 (Active)** – This is an active Contaminated Site (File ID 2543.38.002). Spilled diesel from various incidents at the Icicle Seafoods processing plant since 2005 was placed in this on-site landfarm for treatment. It is actively tested and turned to remediate the contamination. It is located adjacent to the Icicle Equipment Boneyard in the middle of town 350 feet from School Lake.

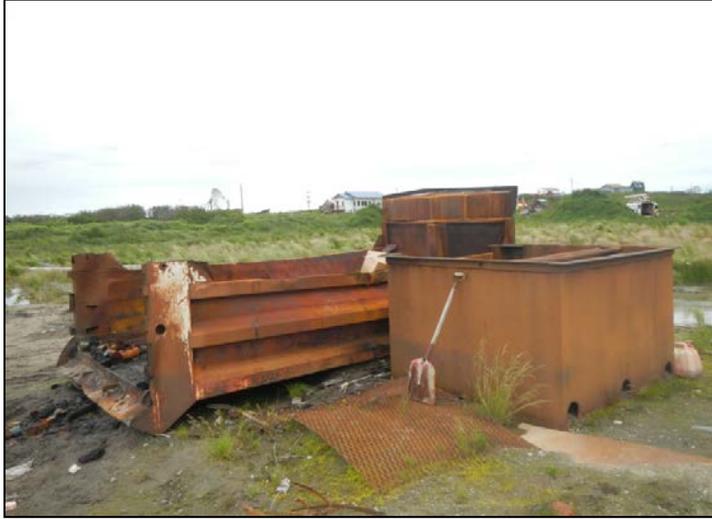
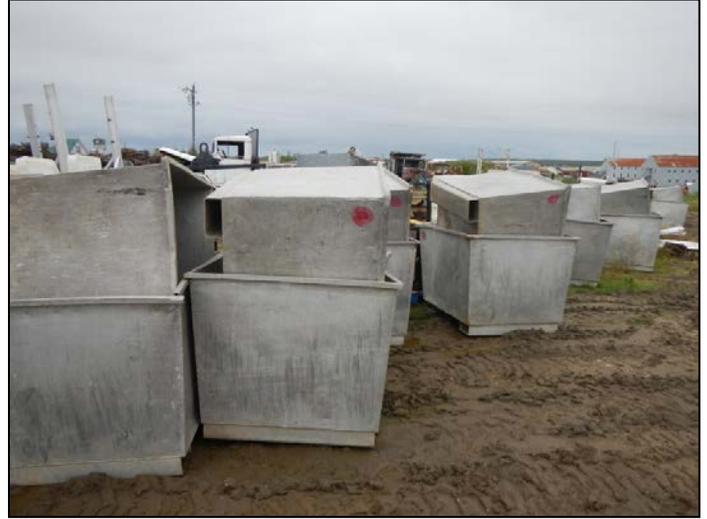
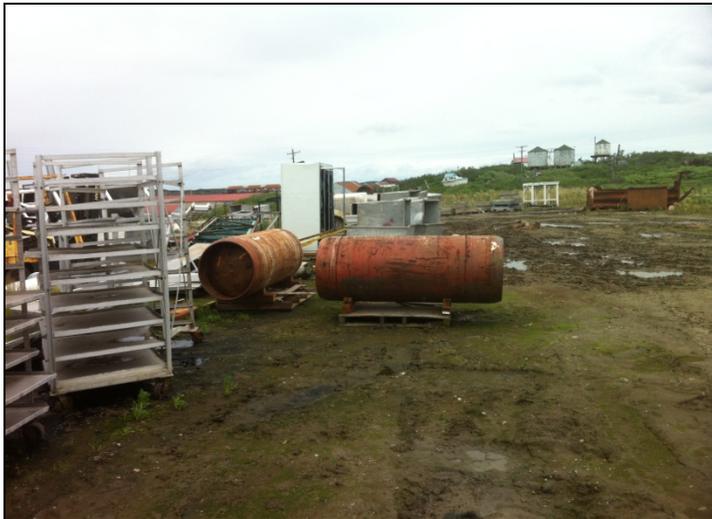
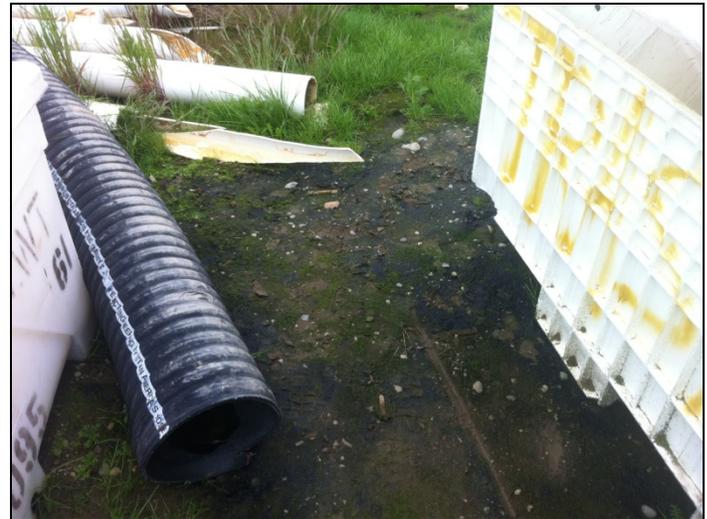
- **Icicle Equipment Boneyard, 58.212922/-157.374031 (Active)** – Icicle Seafoods Inc. operates a boneyard for old cannery equipment, fuel tanks, trucks and heavy equipment at a site adjacent to the contaminated soil near School Lake. Several areas of the bone yard showed petrochemical staining and sheen near tanks and under vehicles. Icicle Seafoods also burns waste in an old dump truck bed at the site. The City reported they have given permission to burn only cardboard, however, there were burned cans and cubes of butter were scattered around the area. The site is approximately 300 feet from a lake and 900 feet from Egegik River.
